Date

2022-01-15

Optical strain measurement and crack detection technique for quasi-brittle masonry materials at high to ultra-high strain rates

RISE Research Institutes of Sweden AB
Chemistry and Applied Mechanics - Mechanical Research and Innovation

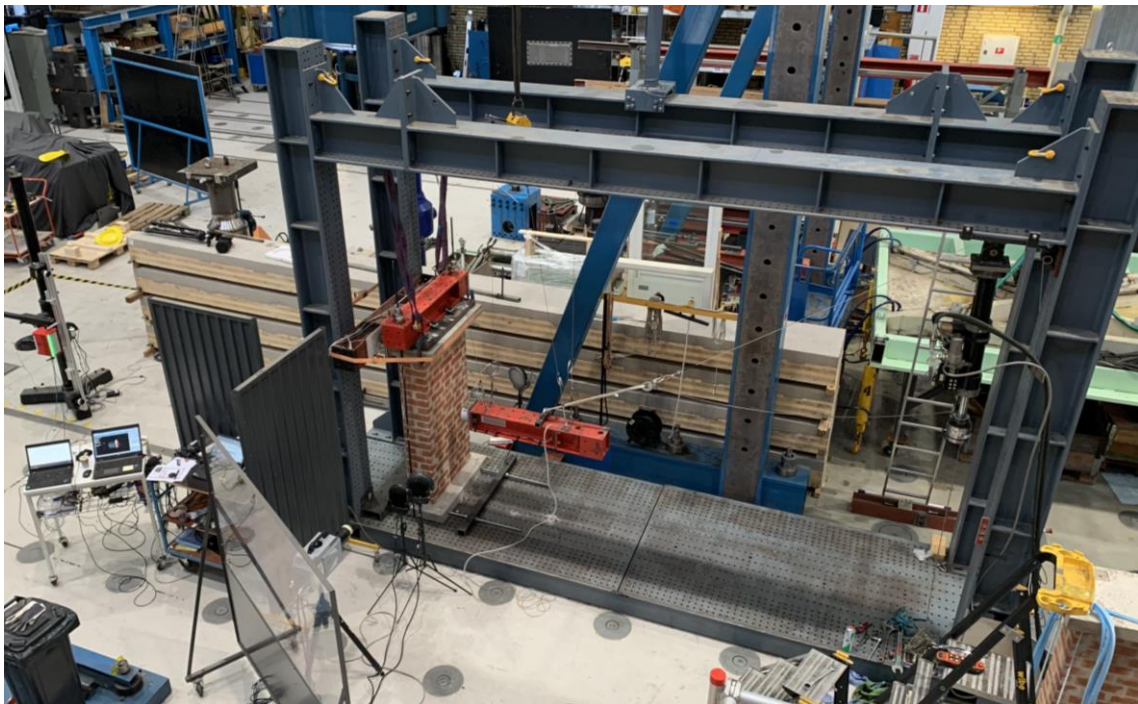
Figure 3 Test setup: schematic (a); bird-eye view taken before test W9-1 (b).

Figure 3 shows the test rig in which the impact tests were conducted. The rig consisted in two steel frames of height 3.5 m and length 5.0 m. The frames were distanced by 1.2 m and mounted on a 220-mm thick steel floor which was, in turn, laid on the laboratory strong floor. The two frames were connected by a 200 × 200 mm HEB steel beam, reinforced by 4 flanges and placed transversally between the frames at 1.6 m from the steel floor (in brown in Figure 3).

The test units were assembled outside the test stand and were moved into it for testing by an overhead crane. In the stand, the lower RC slab was laid directly on the steel floor and pushed, by means of two threaded steel rods, against a 200 × 100 mm steel profile which ensured the force transfer between the slab and the base of the frame. The fixation system for the upper RC slab was designed to allow said slab to move vertically all while minimizing the friction and its rotation. The slab was pushed against the transversal beam and kept against it by a tie-down strap placed around the steel columns (in orange in Figure 3). Two Teflon sheets and an interposed layer of grease were placed between the upper slab and the transversal brown beam. A 50-mm thick steel loading platen was fastened to the top side of the upper RC slab; on the top of it, a 200 × 200 mm steel loading beam was fixed (in red in Figure 3). Finally, the axial force was applied through 2 lateral post-tensioned threaded M16 10.9 steel rods, connecting the loading beam directly to the steel floor. The rods were manually post-tensioned to the intended initial force before each drop.

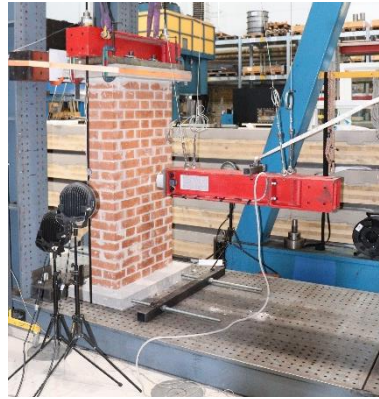
Figure 4 Dropping mass: lateral view.

A pendulum system was used to impact the brick walls. As impacting mass, we used a $800 \times 200 \times 200$ steel HEB beam reinforced at its ends by two 15-mm thick steel flanges (Figure 4a). At the end of the beam impacting the walls, a steel plate with an attached steel bulb was screwed (Figure 4b). the bulb consisted of a steel cylinder with an hemispherical cap Figure 4b). In this basic configuration, the dropping mass weighted 76.5 kg. At the other end of the beam, a short steel beam was attached to reach the final configuration of 116 kg.

Four cables connected the mass to the frame. The dropping system was designed such that the mass kept its horizontal position during the free fall. The impact occurred at the lowest point of the fall, with the impact force directed only in the horizontal direction.

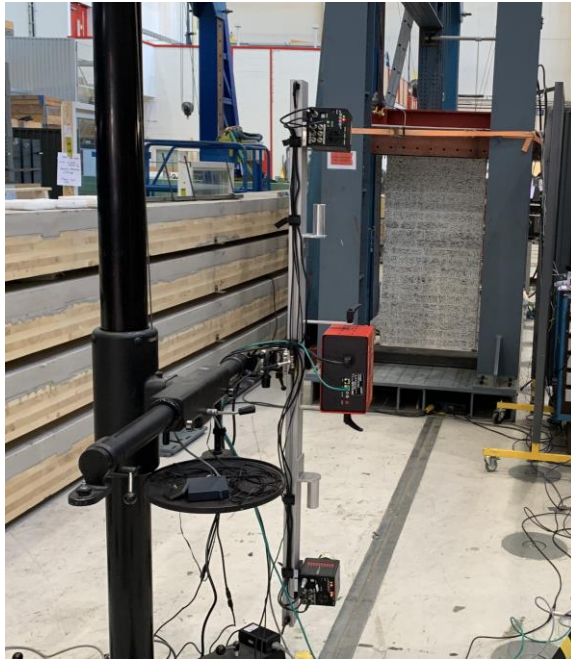
Figure 8 3D high-speed DIC measurements: View of the set-up.

To analyse the dynamic structural response of the masonry walls, 3D DIC measurements based on a stereoscopic camera set-up with two HS cameras were employed. The measurements were used to study, e.g., the crack development, wall uplift, out-of-plane deformations.

Two Photron Mini AX100 cameras were mounted on a rigid aluminium profile with a relative distance of 1.7 m and angle of 24° . The camera set-up was positioned at distance of approximately 4 m from the surface of the walls. On the cameras were mounted 50 mm fixed Nikon lenses and the aperture was set to $f/4$. An image resolution of 1024×720 pixels and an acquisition rate of 5 kHz were used, which corresponds to a time resolution of approximately 0.2 ms. The cameras were synchronized in time by connecting them with a synchronization cable and using a master-slave mode. Before testing, the system configuration was calibrated for a measuring volume of approximately $1565 \times 1120 \times 1120 \text{ mm}^3$ (x, y, z), covering slightly more than the face of the wall. The speckle pattern used for the subset correlations was achieved by first applying white retro reflective paint as background and then black stains using a rough plastic brush. To obtain high contrast levels, during the tests the walls were illuminated by a high-power white LED light panel.

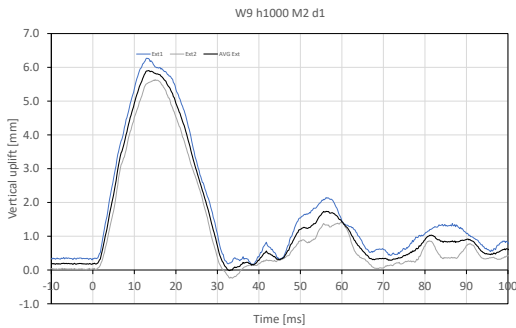
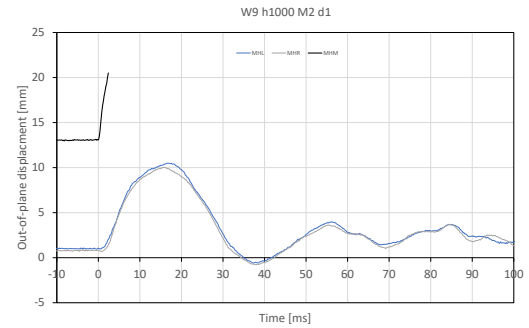
W9-3

Figure 11 Test results – Wall W9-3: (a) Axial load; (b) Acceleration of the dropping mass; (c) displacement of the dropping mass; (d) velocity of the dropping mass; (e) wall uplift; (f) out-of-plane wall deflection.

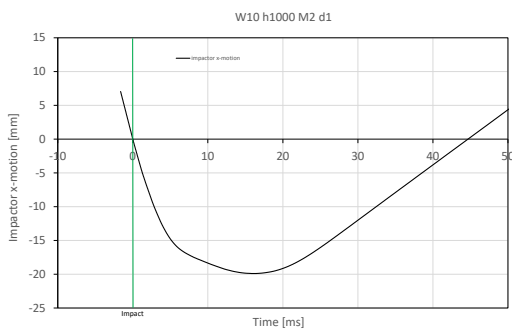
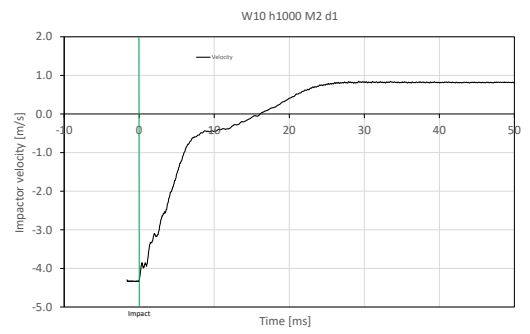
W10-1

Figure 14 Test results – Wall W10-1: (a) Axial load; (b) Acceleration of the dropping mass; (c) Displacement of the dropping mass; (d) Velocity of the dropping mass; (e) Wall uplift; (f) Out-of-plane wall deflection.

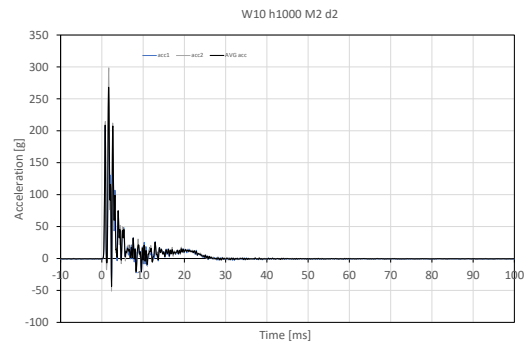
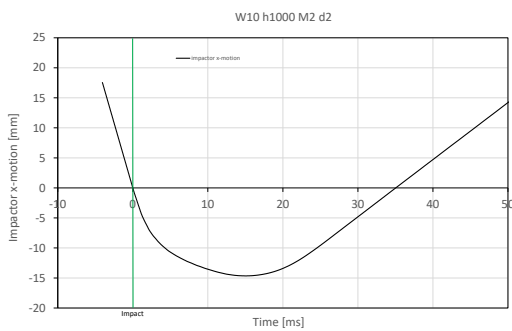
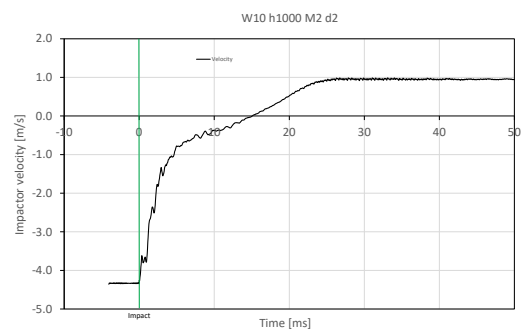
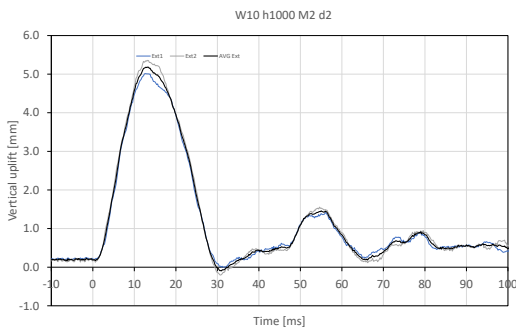
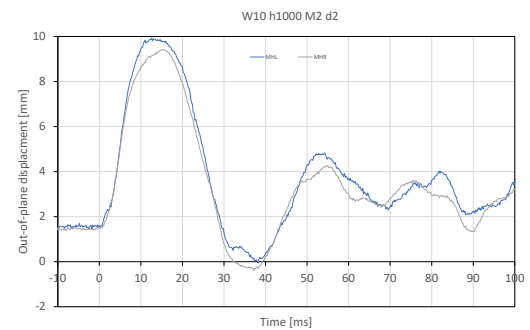
W10-2

Figure 15 Test results – Wall W10-2: (a) Axial load; (b) Acceleration of the dropping mass; (c) Displacement of the dropping mass; (d) Velocity of the dropping mass; (e) Wall uplift; (f) Out-of-plane wall deflection.

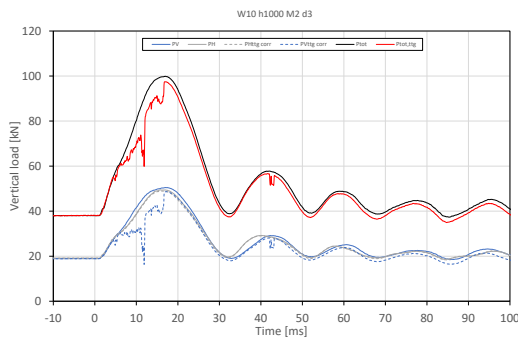
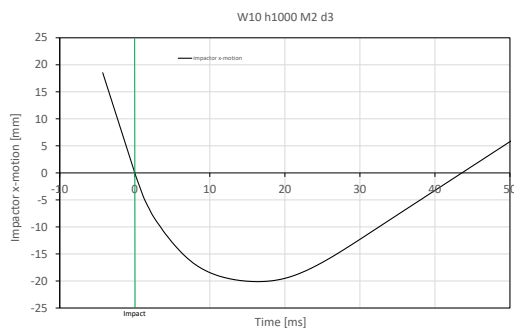
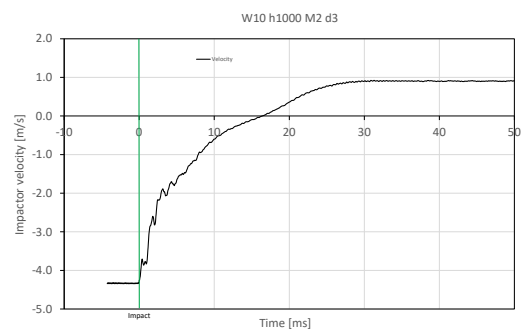
W10-3

Figure 16 Test results – Wall W10-3: (a) Axial load; (b) Acceleration of the dropping mass; (c) Displacement of the dropping mass; (d) Velocity of the dropping mass; (e) Wall uplift; (f) Out-of-plane wall deflection.

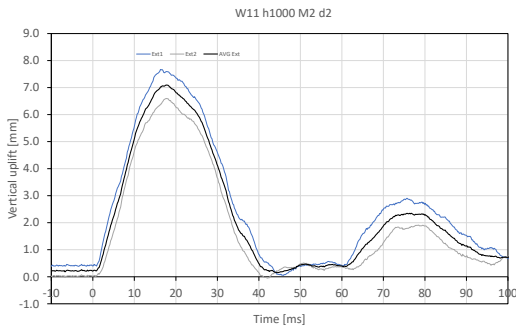
W11-2

Figure 19 Test results – Wall W11-2: (a) Axial load; (b) Acceleration of the dropping mass; (c) Displacement of the dropping mass; (d) Velocity of the dropping mass; (e) Wall uplift; (f) Out-of-plane wall deflection.
