Smart Materials for Early Corrosion Sensing in Fibre Reinforced Plastics – Final report

Love Pallon, Johanna Josefsson
RISE KIMAB

Karin Jacobson
PDS Consulting AB

2019-09-30

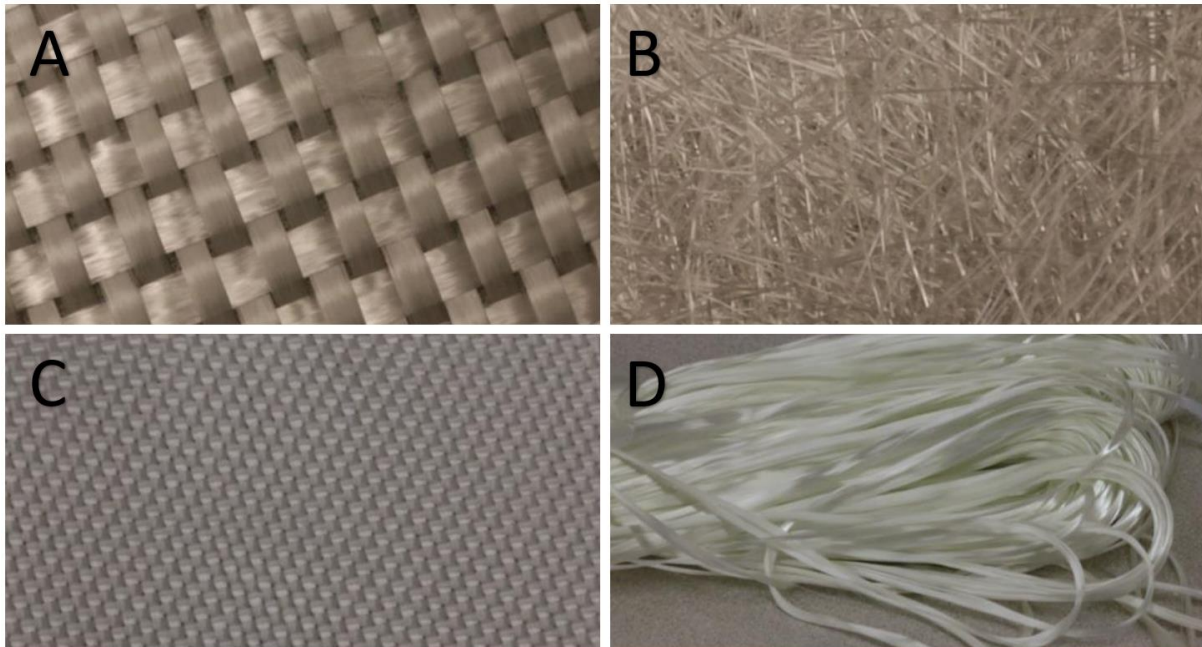
Figure 1. Different structures of glass fibres. Woven roving (A), Chopped Strand Mat, CSM (B), synthetic woven polyester (C) and roving (D). [1]

In order to design the mechanical properties of the material, different glass fibre structures are used. Some examples are shown in Figure 1, there are also other kinds of glass fibre structures on the market. Chopped strand mat (CSM), woven roving and roving are used for FRP materials for the processing industry. The glass fibres in the CSM mat has no general direction, while in the woven roving mat, the glass fibres have two distinct directions, this results in different properties of the final laminate. There are also different types of glass available on the market, the dominating ones being; E-glass, C-glass and ECR-glass. E in E-glass stands for electrically insulating. C in C-glass is for chemical resistance. ECR-glass has properties somewhere in between E-glass and C-glass. Depending on the application in which the FRP shall be used the manufacturing technique can be either by hand lay-up or by machine. With a machine it is possible to exactly control the angles between the fibres and in that way design the mechanical properties in precisely the right way for the application, see Figure 2. When making a laminate by hand it is not possible to control the structure in the same way as with machines, it is more of a craft. [1]

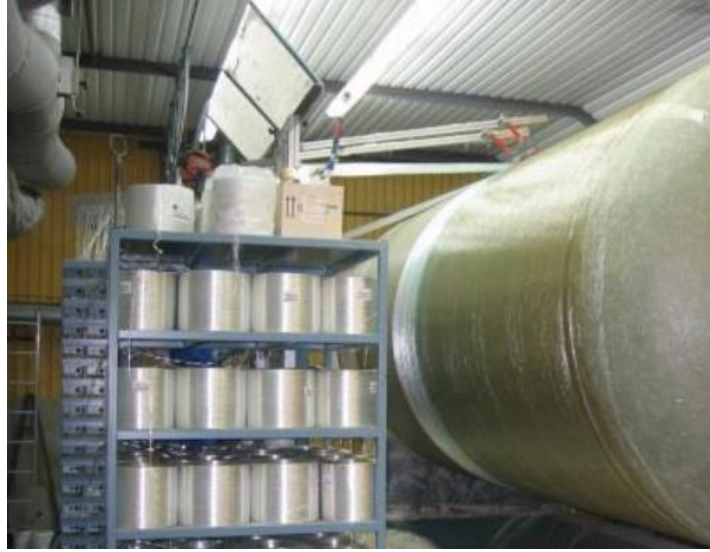
Figure 2. Manufacturing of tank in FRP made by a machine. [1]

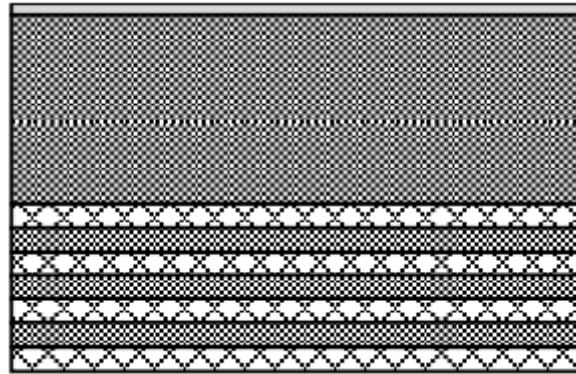
Figure 3. Schematic picture of an FRP laminate, at the top the corrosion barrier (red arrow) and at the bottom the structural bearing layer. [1]

Figure 3 shows a schematic view of a general laminate build up for FRP used within processing applications. Closest to the chemical there is a resin rich corrosion barrier (about 2.5 to 5 mm thick) with a low content of glass (in the top of the figure). The glass fibre in this layer is usually a surface veil and chopped strand mats (CSM), i.e. it has no general fibre orientation. Outside this is the structural bearing layer with much higher glass content, usually wound fibre and/or woven fibre mats with a preferential fibre direction (in the bottom of the figure). [1]

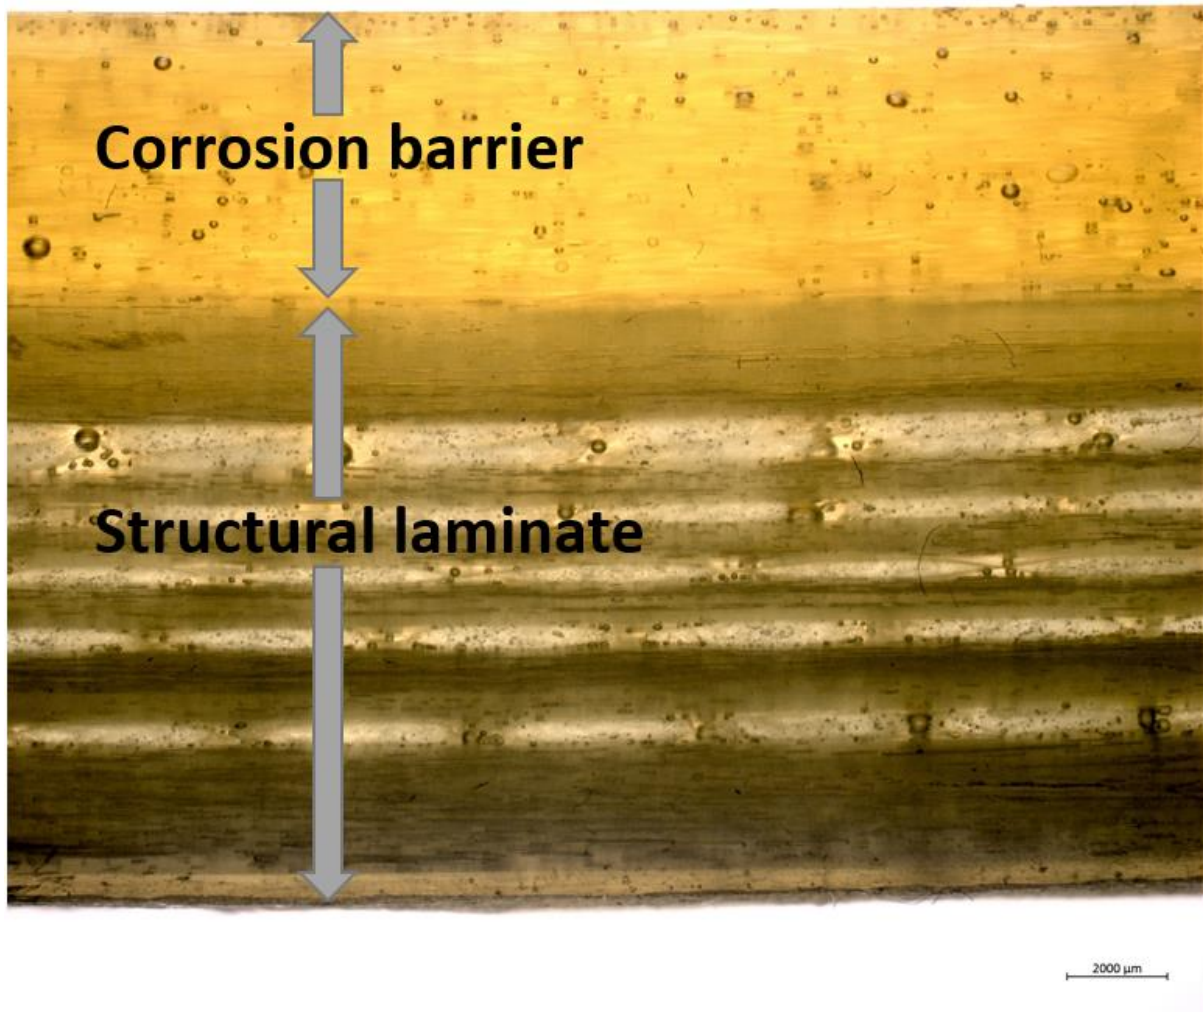
Figure 4. Cross section of a typical GRP laminate for corrosive environments showing the corrosion barrier and the structural laminate.

Figure 4 shows a cross section of a real FRP laminate, here the corrosion barrier layer and the structural bearing layer clearly can be seen. The corrosion barrier is not load bearing and corrosion of this layer can be allowed. However, no corrosion can be permitted in the structural support layer since that can result in decreased mechanical properties for the construction.

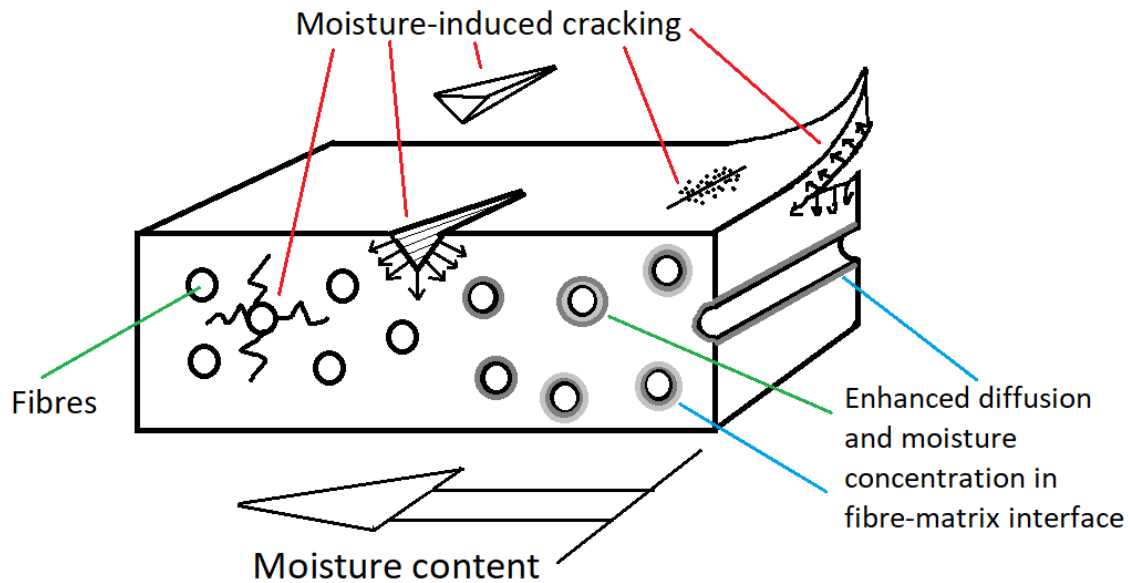
Figure 5. Schematic picture of the effect moisture can have on FRP.

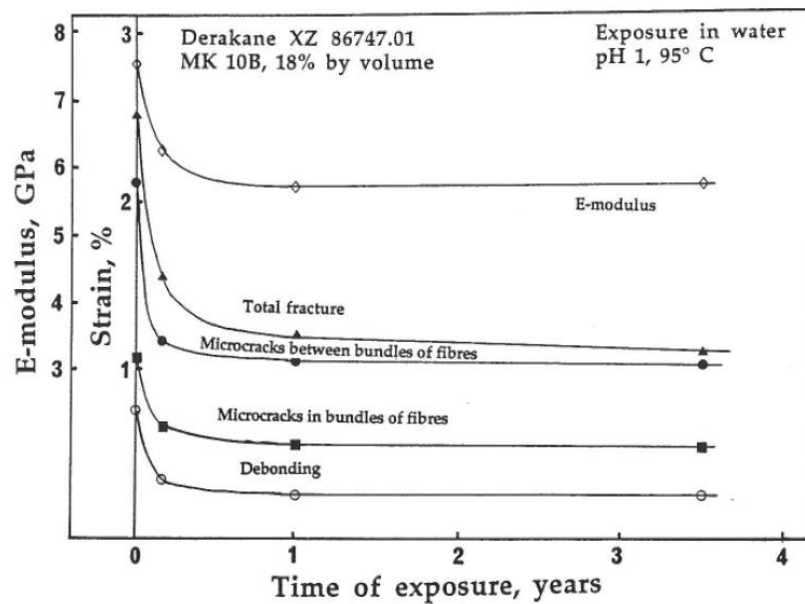
Figure 6. E-modulus and strain as a function of time for an FRP material exposed in water. [3]

Water can have a big influence on FRP materials. When water diffuse into the material the E-modulus will decrease as can be seen in Figure 6. [3] Depending on which type of resin that is used the diffusion of water will vary between materials. Water molecules can also diffuse into the resin via osmosis to be dissolved and eventually forming blisters. If the pressure inside the blisters gets too high, they can crack and cause failure of the structure. Delaminations of layers inside the composite is another defect that can be seen in FRP and in worst case scenario they can cause failure of the structure. [1]

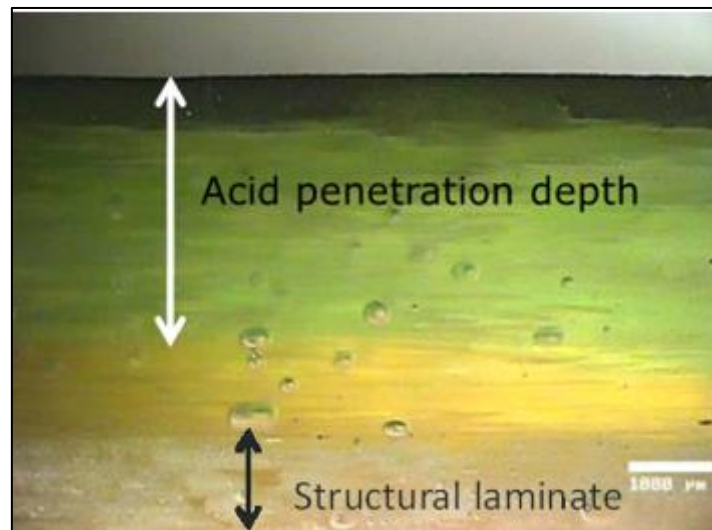
Figure 7. Hydrochloric acid penetration, seen as a green discoloration, in the corrosion barrier.

An example of a common corrosion problem for the processing industry is attack of HCl on FRP, see Figure 7. The picture shows a cross section of a laminate that has corroded due to penetration of hydrochloric acid. Here the corrosion can be seen as a green discoloration in the laminate (upper part of the cross section) and it is clear that the acid has penetrated about 2/3 of the thickness of the corrosion barrier. When a cobalt accelerator is used in the material the laminate is colored green by the hydrochloric acid. But if cobalt had not been used the penetration of acid cannot be seen. As said earlier corrosion of the corrosion layer can be permitted but as soon as it reaches the structural bearing layer it cannot be tolerated since this will lead to changes of the mechanical properties of the laminate structure. Because of this it is very important to be able to detect the rate of the corrosion into the laminate. One example of

a corrosion mechanism that can be found after attack of HCl is micro delaminations in the corrosion barrier. Today the only safe method to do this is to take out a physical sample from the process equipment and polish a cross section of it as in Figure 7. This is often not easily done and requires a shut down of the system in order to take out a sample for analysis.

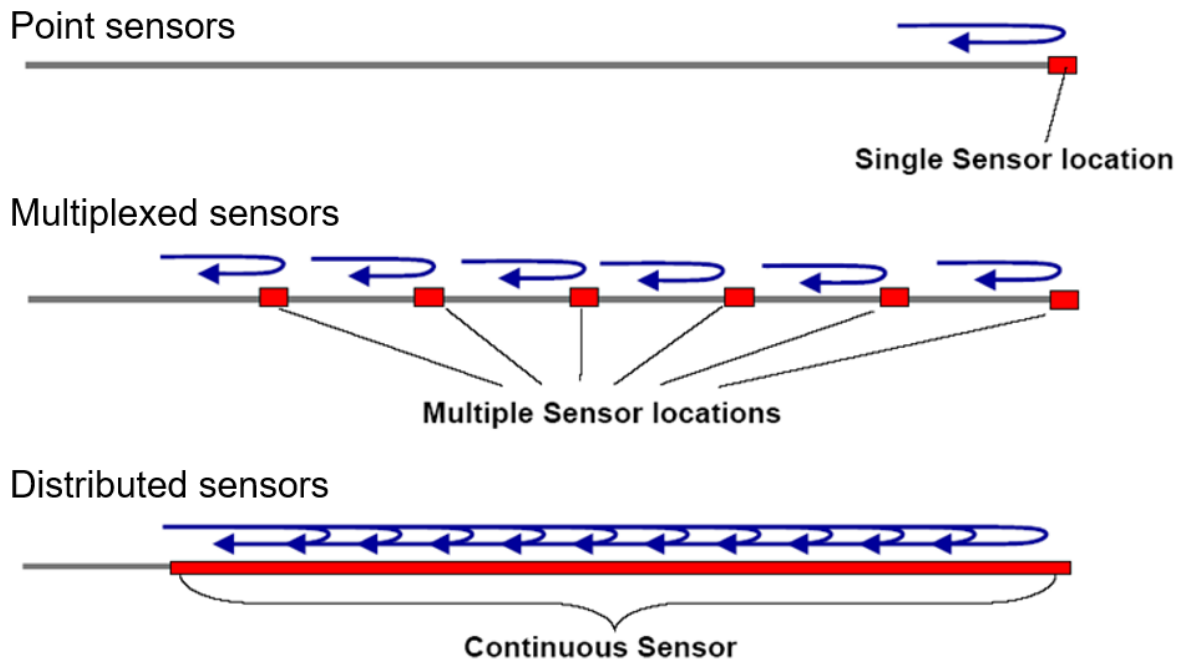
Figure 8. Different types of optical fibres.

There are different types of optical fibre sensors, as can be seen in Figure 8. A point sensor only has a single sensor location while a multiplexed sensor has multiple sensor locations along the fibre. Distributed sensors have a continuous sensor along the whole length of the fibre.

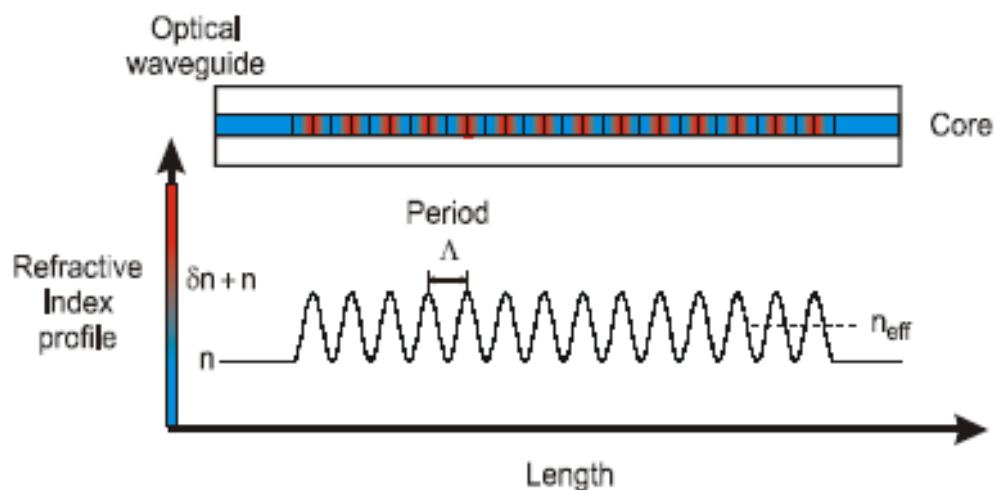
Figure 9. Schematic picture of a Fibre Bragg Grating (FBG) sensor.

An FBG-sensor (Fibre Bragg Grating) has a periodic or almost periodic structure consisting of a variation of e.g. the refractive index, along the length of the waveguide. A schematic picture of an FBG-sensor can be seen in Figure 9 and Figure 10. The refractive index profile will give a change in the spectral response, so that the transmitted and reflected light will give a fingerprint of the specific refractive index profile of the optical fibre.

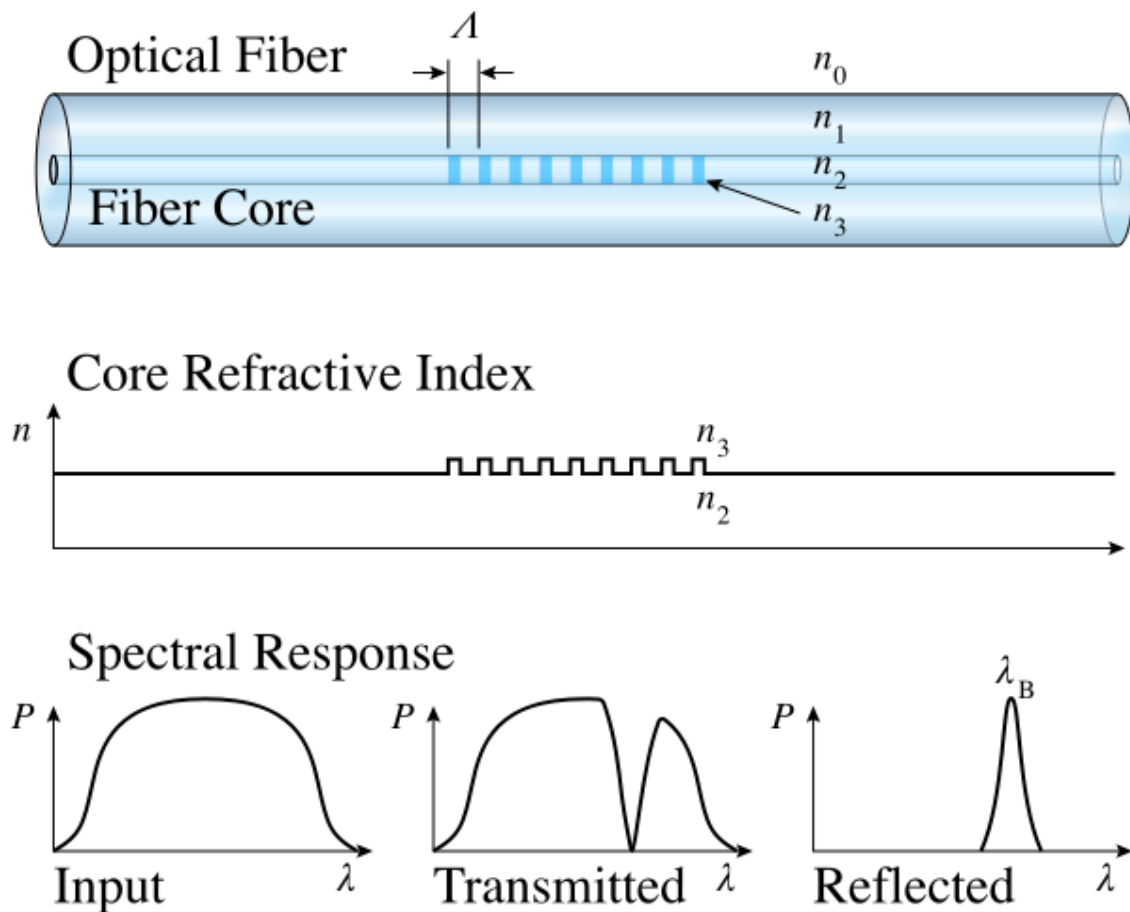
Figure 10. Schematic picture showing how the spectral response is affected by the core refractive index.

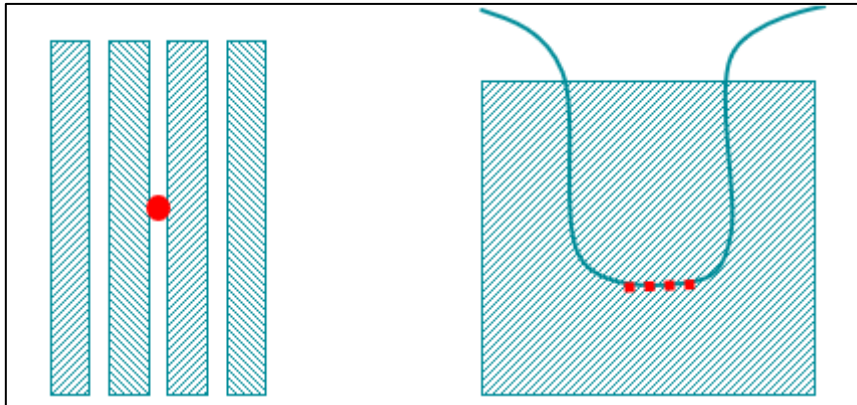
Figure 11. Schematic illustration of the FBG sensor in the middle (red) of four CSM layers.

As a start, two types of FBG sensors were laminated into FRP samples, see Figure 11, one of the FBG sensor being a polyimide coated fibre and one an acrylate coated fibre.

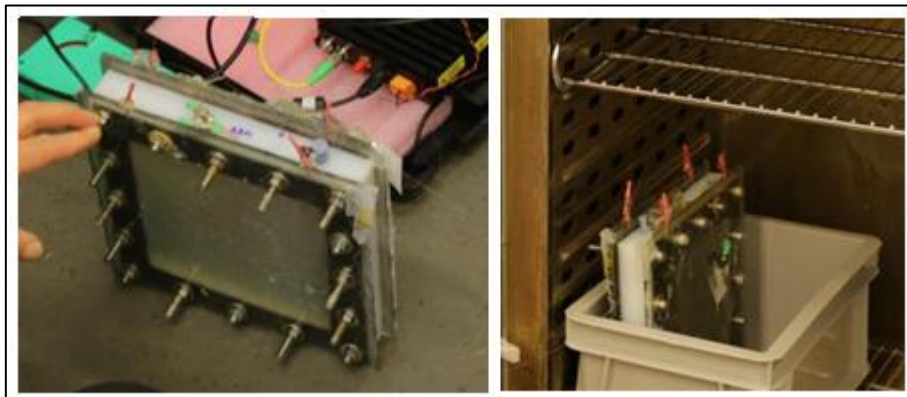
Figure 12. The experiment setup for the single sided exposure to water at 70 °C.

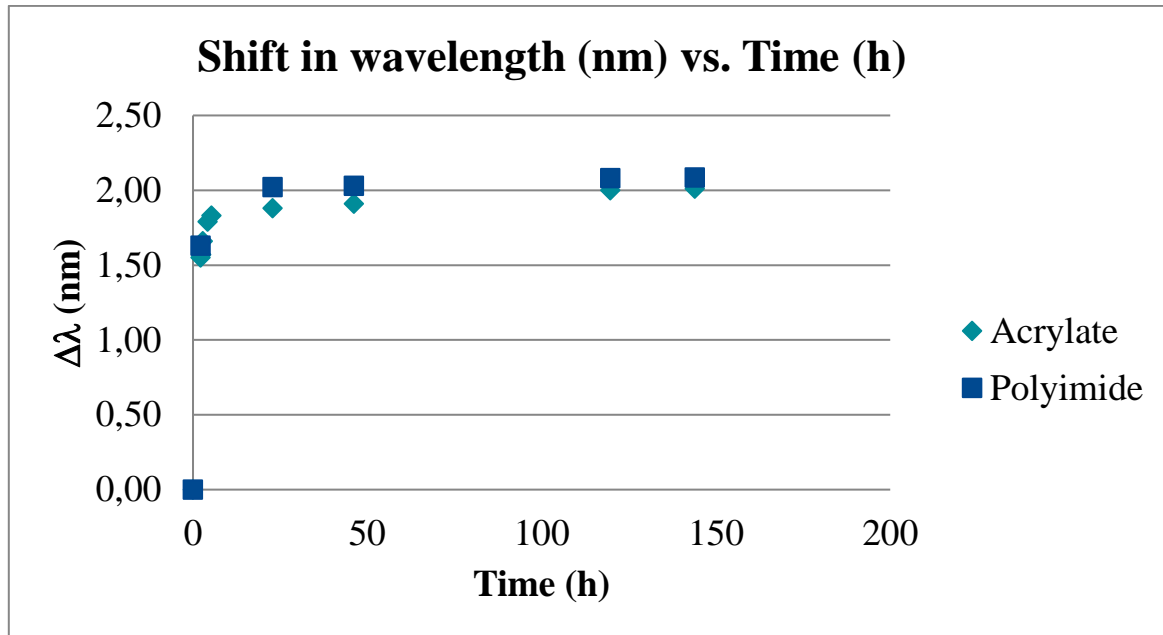
Figure 13. Results from the single sided exposure of GFRP laminate to water at 70 °C.

The FRP laminates cured and, after curing, they showed a shrinkage that could be recorded by the sensors, therefore the experiment can be considered promising. The laminate was tested in an oven at 70 °C with single sided exposure to water, see. The results of this experiment showed that the wavelength increased with time, which corresponds to the thermal expansion of the laminates. These results can be seen in Figure 12.

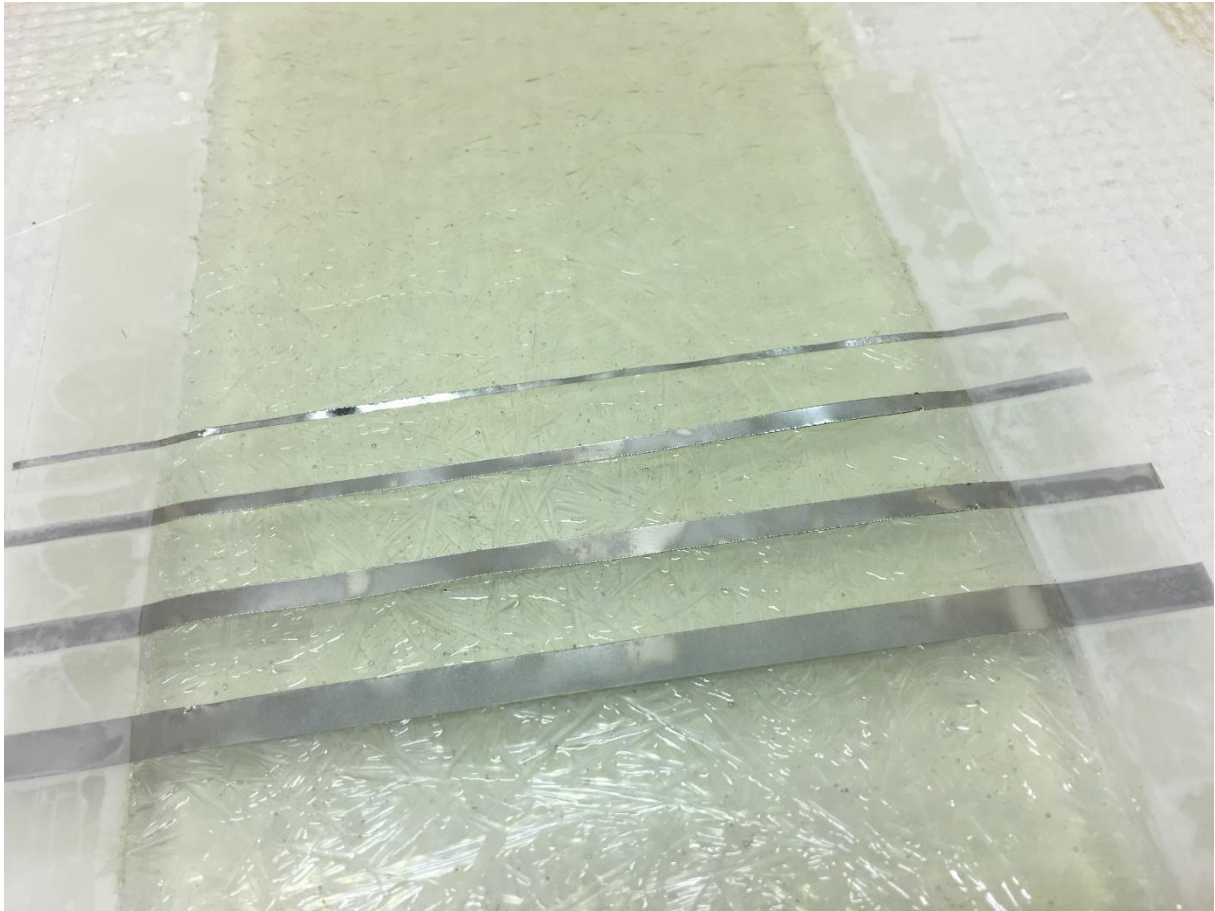
Figure 14. The FRP sample during manufacturing, the position of the thin metal films can be seen.

Four different sized thin metal films were incorporated into FRP laminate, as can be seen in Figure 14. Three of the thin metal films were successfully coupled to cables with different colors to be able to measure the resistance, see Figure 15 and Figure 15.

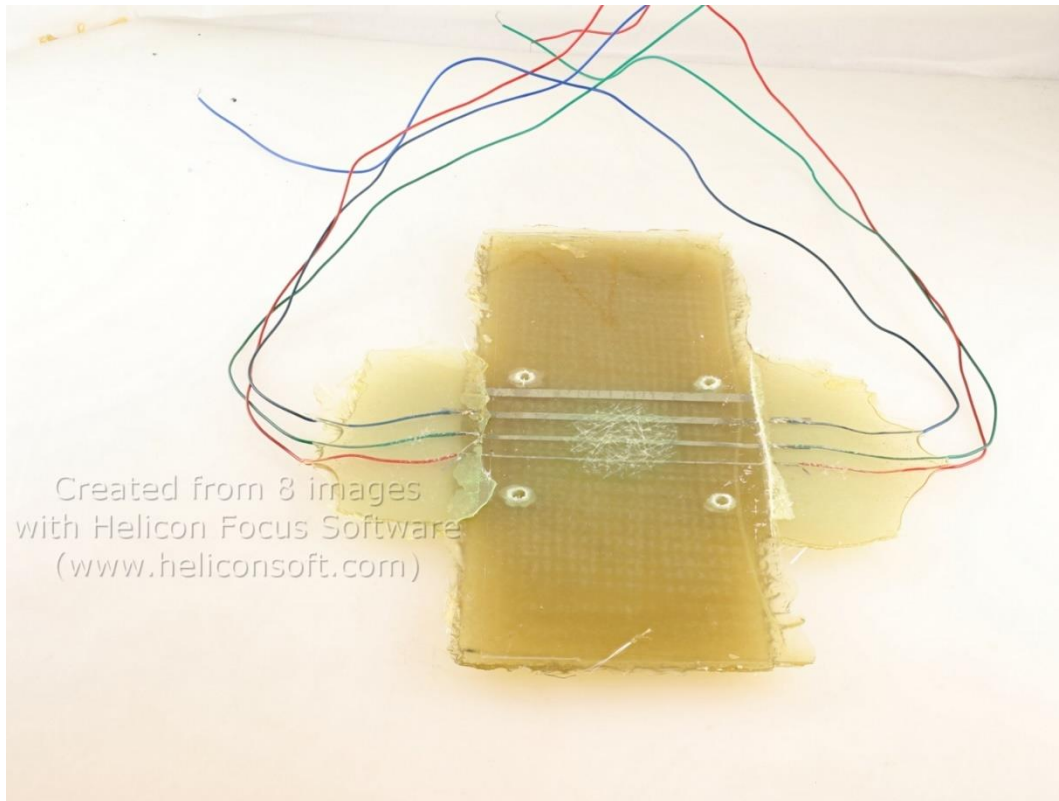
Figure 15. The finished sample with cables coupled to the thin metal films inside.

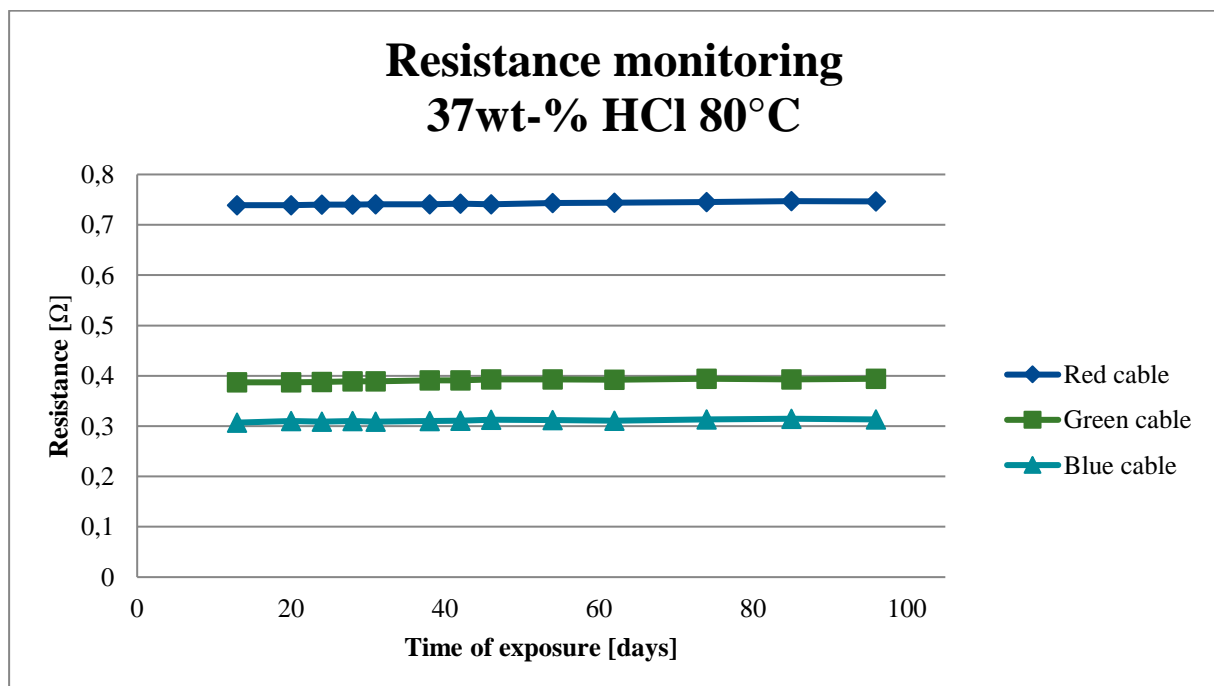
Figure 16. Resistance versus time of exposure for the three thin metal films incorporated in the FRP laminate.

The FRP sample was exposed on one side to concentrated HCl at 50 °C in an oven. During the whole exposure time of 90 days, the resistance of the incorporated metal films was measured. The results are illustrated in Figure 16, the resistance versus exposure time.

As can be seen the resistance did not change over the exposure time at any of the thin metal films. The reasons for this can be several but two possible causes are: too short exposure time so that the acid didn't diffuse all the way to the metal films and/or lack of oxygen inside the FRP laminate to cause metallic corrosion/change in conductivity.

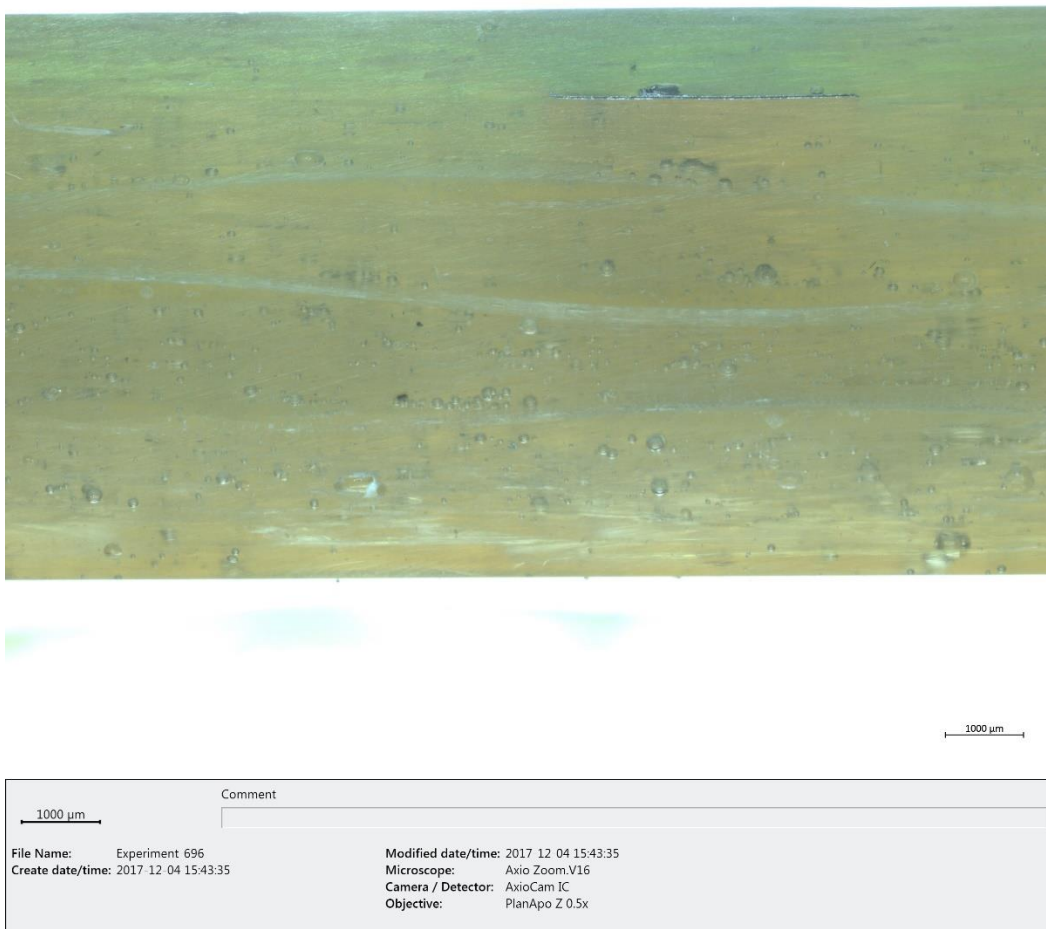
Figure 17. Microscopic picture over the cross section of the laminate with incorporated thin metal films after 90 days exposure in HCl.

Microscopic images were taken on cross sections of the laminate to see how long the acid had penetrated, see Figure 17. It is very hard to tell if the acid diffusion reached all the way to the thin metal films or not. Further investigations are needed in order to evaluate this method more thoroughly.

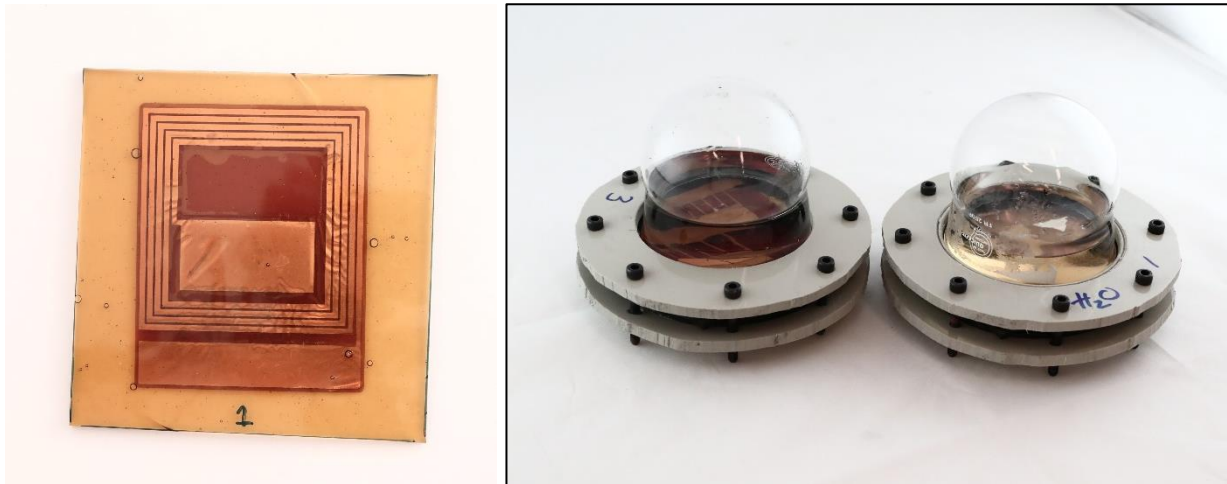
Figure 18-2. Sample 1 (a) before exposure and (b) sample 1 and 3 as mounted for single sided exposure in water at 70 °C. The same setup was used for Sample 3 but then turned upside down to expose the FRP-laminate for HCL gas.

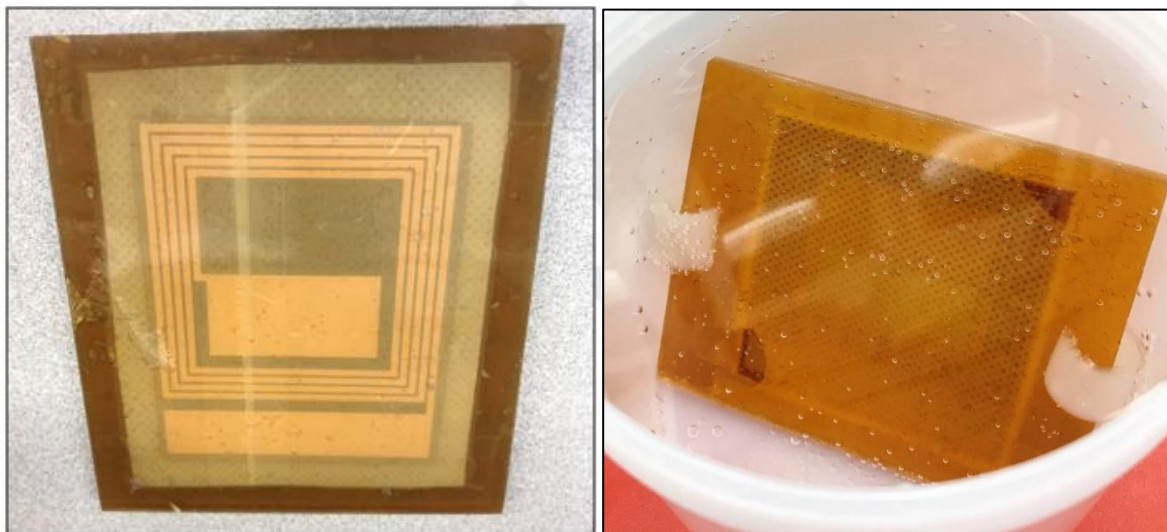
Figure Invi-3. Sample 4 with an InviSense-sensor incorporated in an FRP laminate. To the left (a) the sample before double sided exposure in distilled water and to the right (b) the same sample immersed in distilled water. Sample 5 looked the same as sample 4.

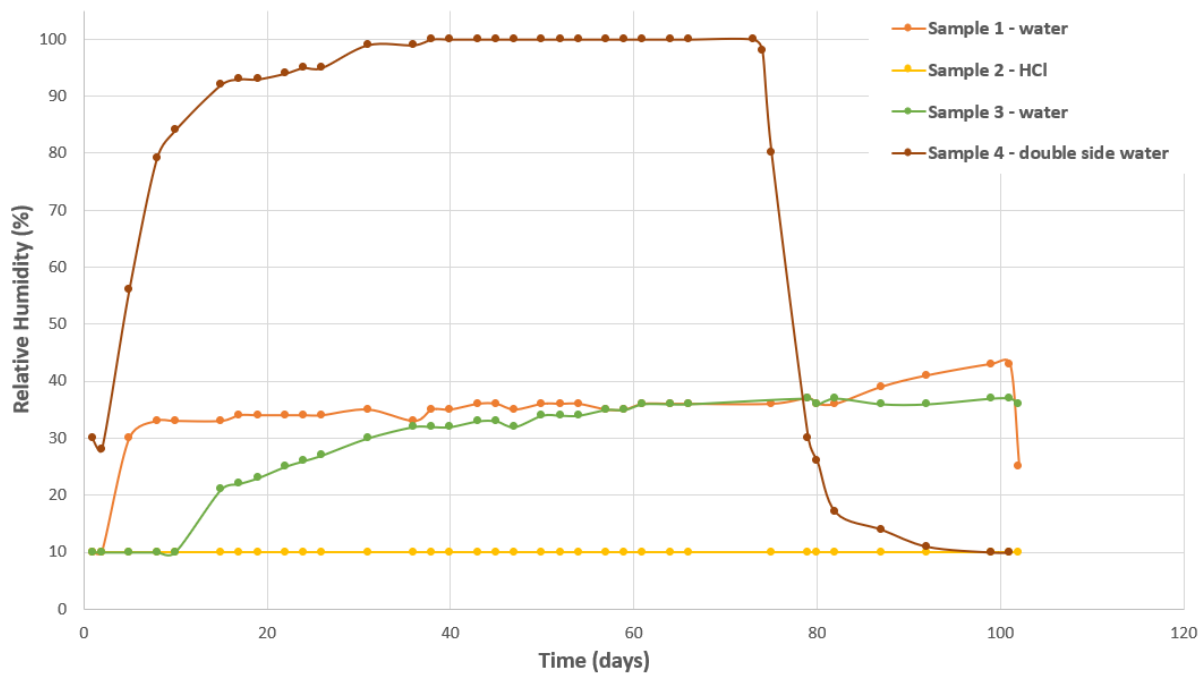
Figure 19. Relative humidity plotted against time of exposure.

Figure Invi-4 shows the relative humidity of sample 1-4 up to 100 days of exposure. Sample 1-3 had before curing an RH around 25%, once embedded and cured the sensors all dropped to a relative humidity of 10 %. It seems as during curing water is removed from the sensor to the resin. The same behavior was not seen for sample 4 and 5 that had glass fibres (CSM) on top (and a different plastic cover), during curing they did not go down in RH. Probably an effect from being more protected from the resin or larger air voids in the vicinity to the sensor. Once exposed it can be seen that the fully immersed sample (sample 4) rapidly increases in RH but does not reach 100% until after 30 days. After 80 days the sample was removed from the water

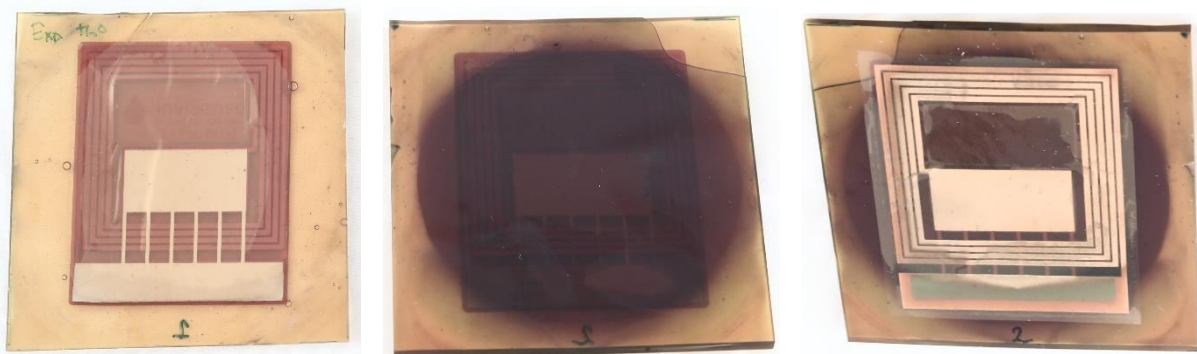
Figure 20a-c. Sample 1 and 2 after single side exposure to (a) water and (b) HCl where the backside of the HCl is seen in (c).

Figure Invi-6a-c shows sample 1 and 2 after exposure. Sample 1 shows no visual difference in the material after exposure, this since there were no glass fibres on top of the sensor. For sample 2, exposed to HCl a brown discoloration can be seen (exposed surface in Figure Invi-6b and backside in c), which is a result of a chemical attack of the HCl on the resin.

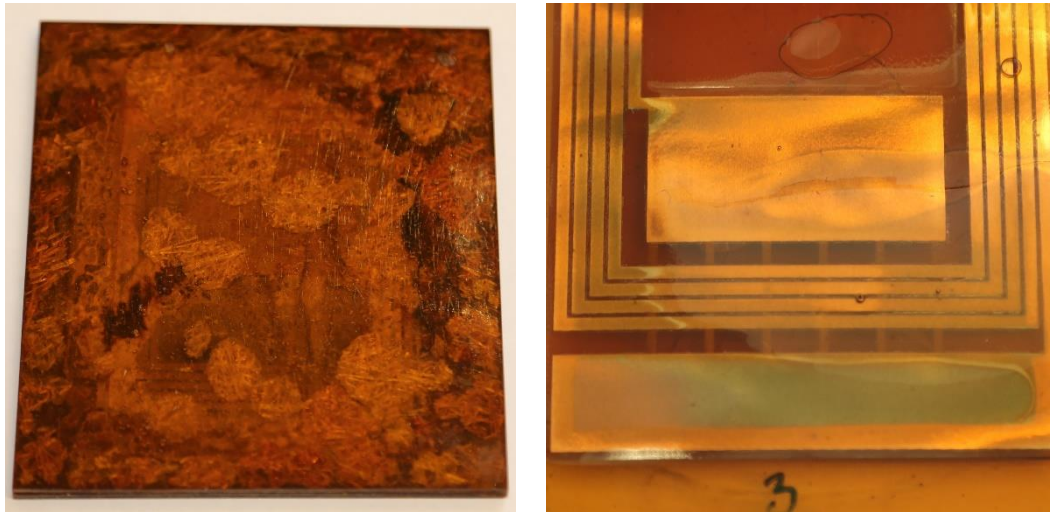
Figure Invi-7a. Sample 5 after exposure in the flue gas stack and (b) the backside of sample 3 after exposure, where it can be that the copper has turned green due to corrosion.

After exposure it can be seen for all transparent samples that the copper has partially corroded and turned green. In Figure Invi-7b the backside of sample 3 is shown, where large areas in connection with the resin turns green. It is unclear why the copper corrodes when in contact

with the resin. It might be a combination of contact with the resin and elevated temperatures. Usually this green discoloration is associated with sulfuric corrosion compounds of the copper.

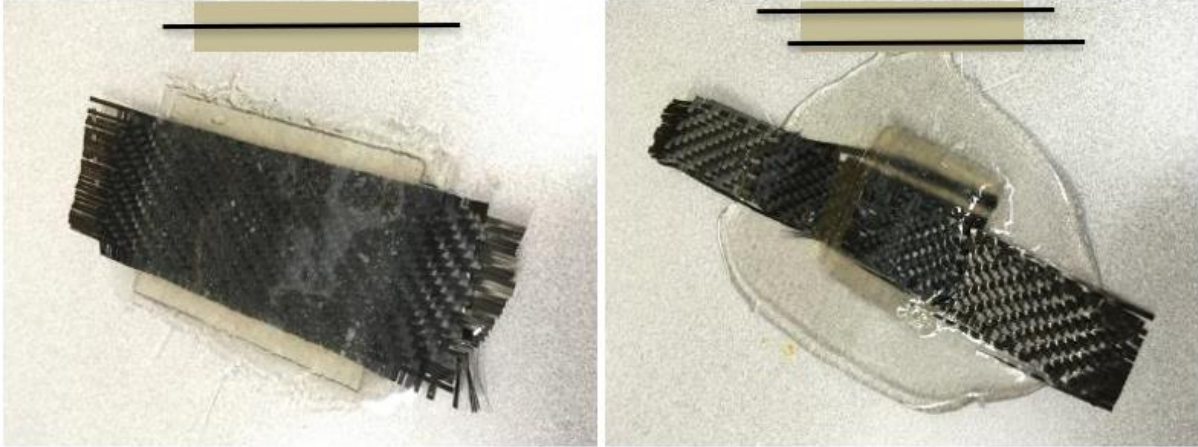
Figure 22. To the left single strand CF, to the right double strand CF samples.

In Figure 22 the single and double strand CF samples can be seen. The inclusion of conductive CF enables the possibility to simplify continuous or long-term measurement at a single spot over time. CF can be introduced in common glass fiber plastics without compromising other properties, it is thus a feasible way to include a permanent sensor.

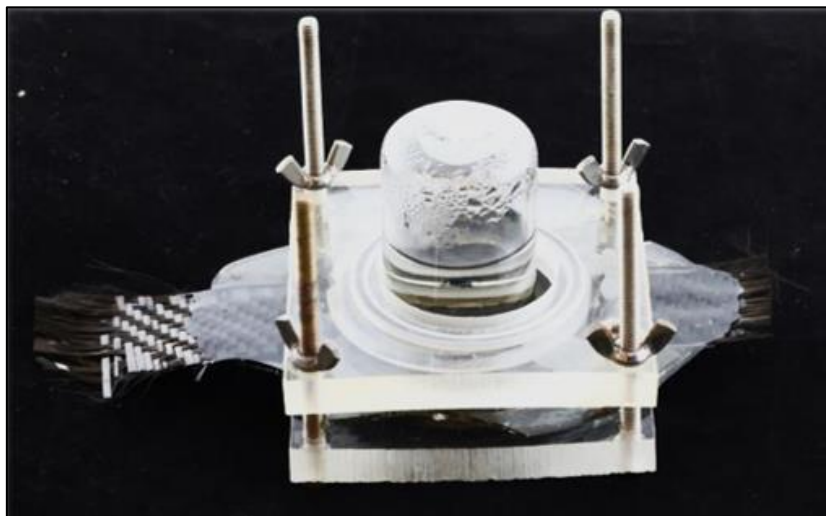
Figure 23. Single sided exposure of sample 4.

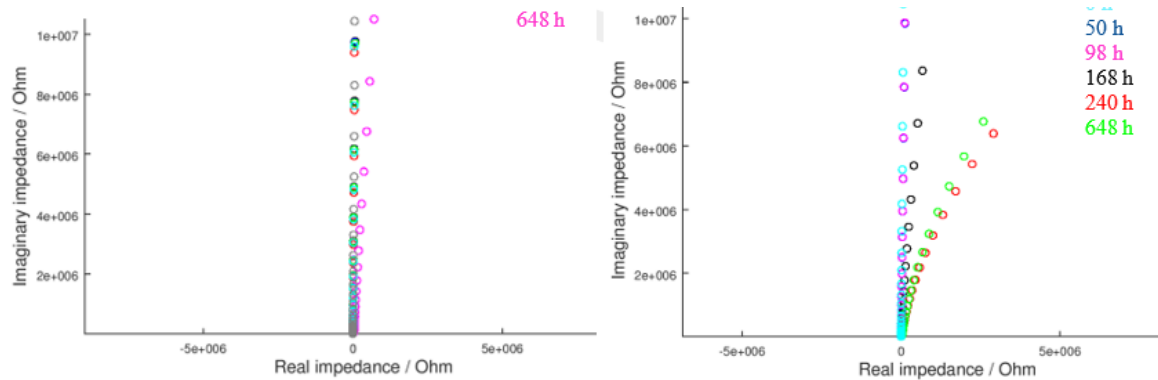
Figure 24a and b. Nyquist plot of sample 1A exposed to (a) water and (b) hydrochloric acid.

Figure 24 shows the Nyquist plot of Sample 1A (no GF) exposed for H₂O and HCl up to 27 days.

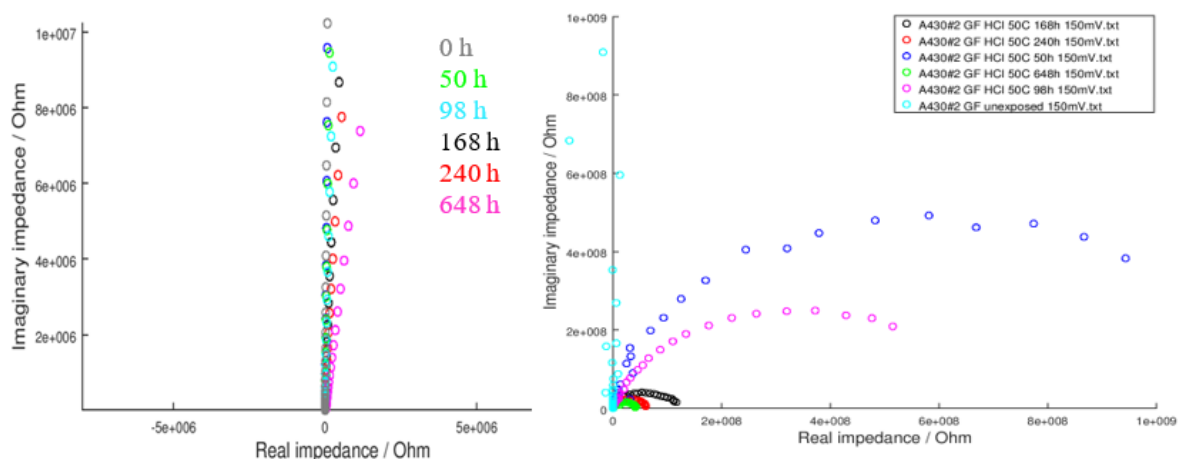
Figure 25a and b. Nyquist plot of sample 2A exposed to (a) water and (b) hydrochloric acid.

In Figure 25, when the clear cast is exposed to water a deviation from straight vertical line, and purely capacitive behavior, can be detected after 648 h (27 days). This indicates ionic conduction which may seem unexpected for the H₂O-exposed sample but may be explained by dissolving of salts from the glass fibres. A process known to be the reason for blistering, where dissolved salts in the FRP creates an osmotic pressure and a driving force for increase water diffusion into the material. For the same sample, but exposed to HCl, the loss of purely capacitive behavior was seen already after ca 100 hours. After this the ionic conduction increased steadily. The same behavior was also seen for sample 2A but not with as high conduction.

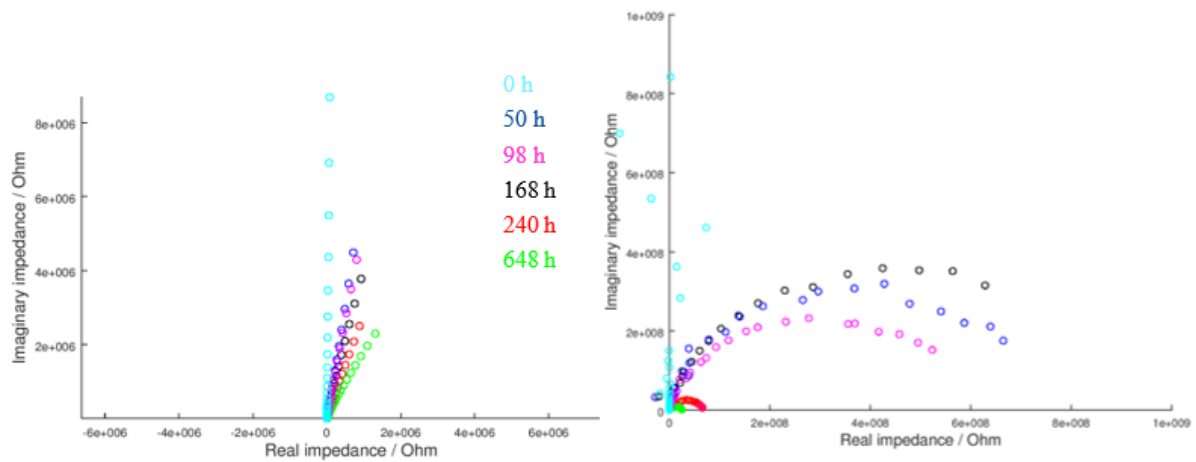
Figure 26a and b. Nyquist plot of sample 2B exposed to (a) water and (b) hydrochloric acid.

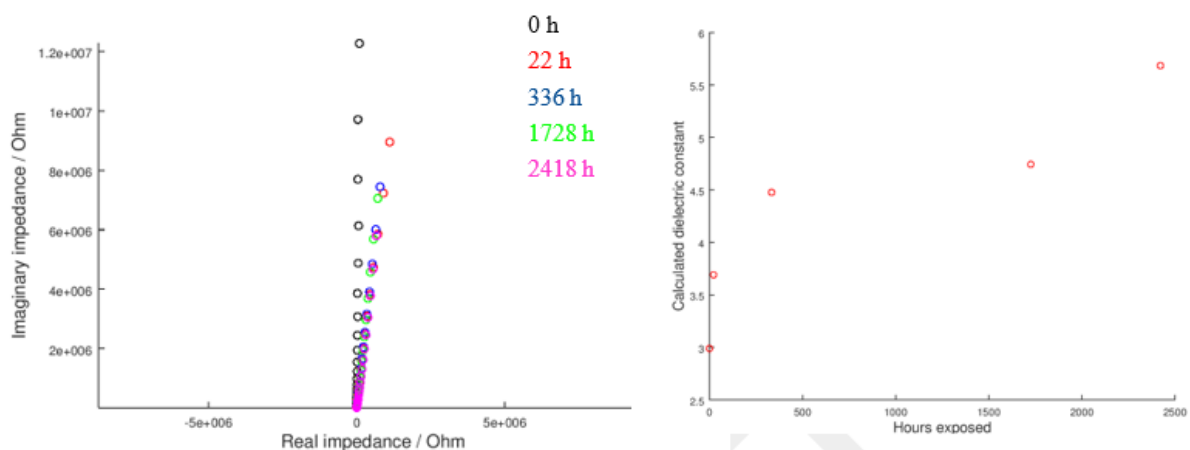
Figure 27. Nyquist plot (a) of Sample 3 and the calculated dielectric constant as a function of time exposed to water.

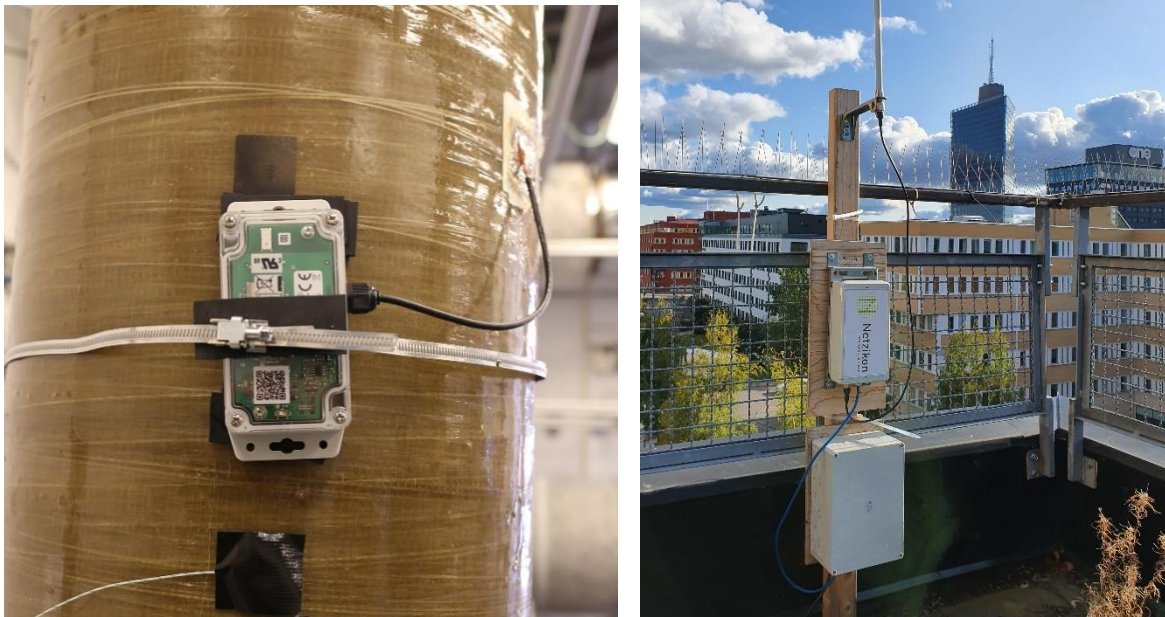
Figure L2: The sensor housing containing the radio sensor with a connected piezo crystal mounted on an FRP-construction. Figure L3: The gateway installed on the roof of the building communicating with the installed sensors and enable the data online.

equipment. The sensors are coupled with an online device and uses SHM (Structural Health Monitoring) and CMS (Condition Monitoring System) to enable continuous monitoring of FRP-construction. The developed device (Figure L2) is attached to an FRP pipe, and from the sensor device a piezo crystal is connected and mounted onto the FRP-composite to generate and detect reflected lamb waves in the frequency range of 216 ± 50 kHz. The detection of relative changes in the material is performed in the connected sensor device by a custom-made analytical software. Each sensor can cover in total 6 m of FRP, 3 meter in both directions, assuming a construction with not to large diameter.

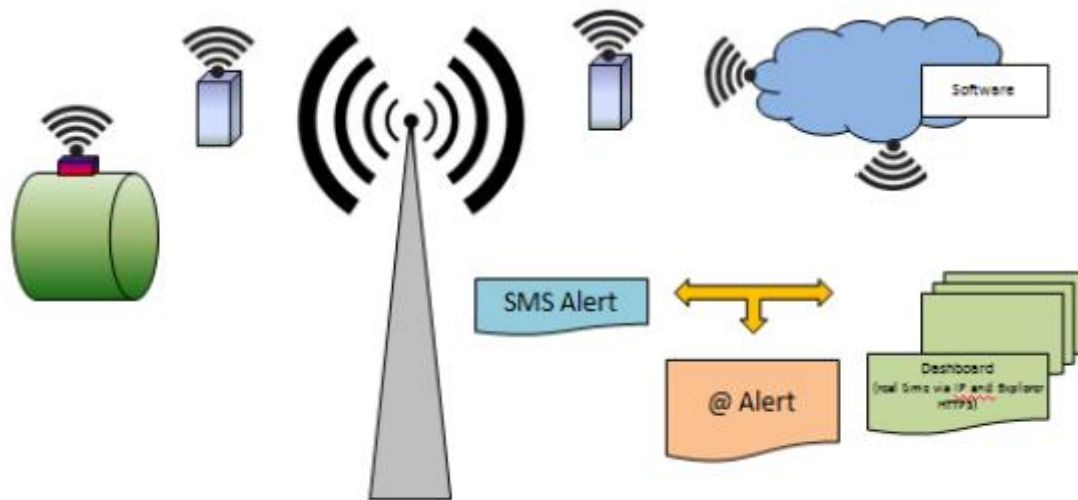
Figure L4: Smart network that enables online monitoring with a large number of installed sensors.
