Smart Materials for Early Corrosion Sensing in Fibre Reinforced Plastics – Final report

Love Pallon, Johanna Josefsson
RISE KIMAB

Karin Jacobson
PDS Consulting AB

2019-09-30

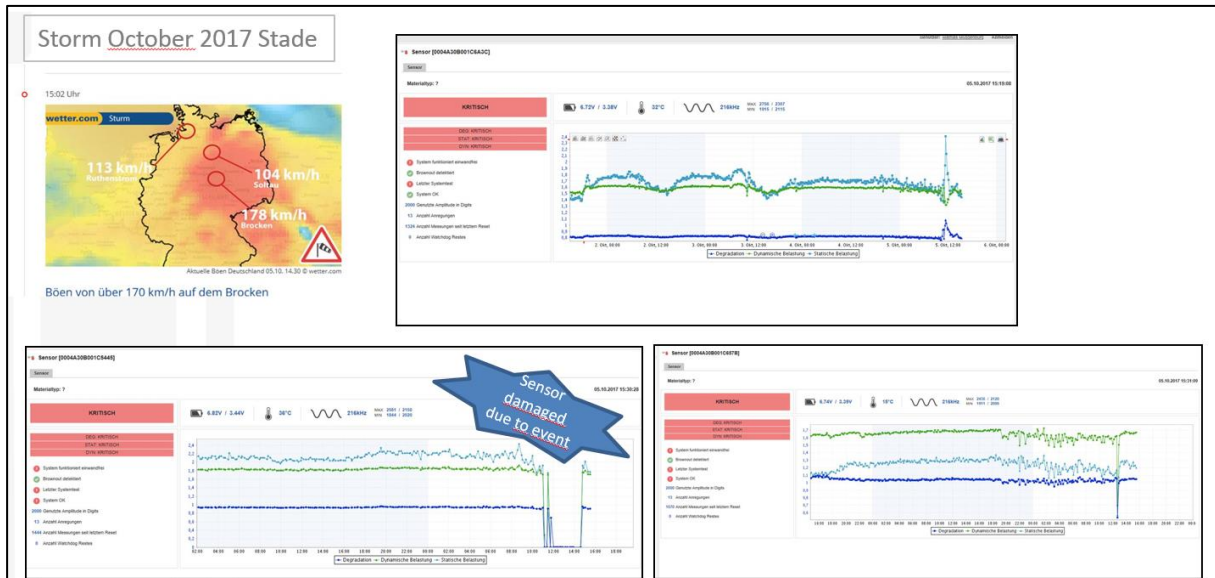
Figure L5. During a storm a tree fell on a pipe which was detected by the lamb wave sensor technology.

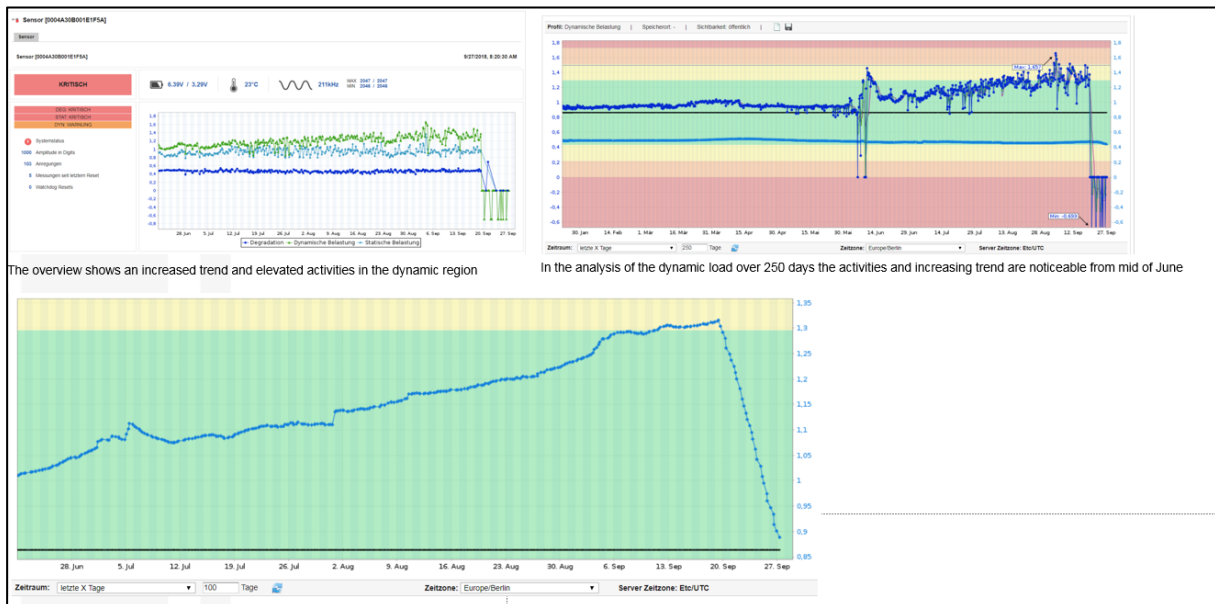
The overview shows an increased trend and elevated activities in the dynamic region

Figure L6. A steady increase in the dynamic region was seen for a time period of three months until the signal deviated more than 50 % from the baseline.

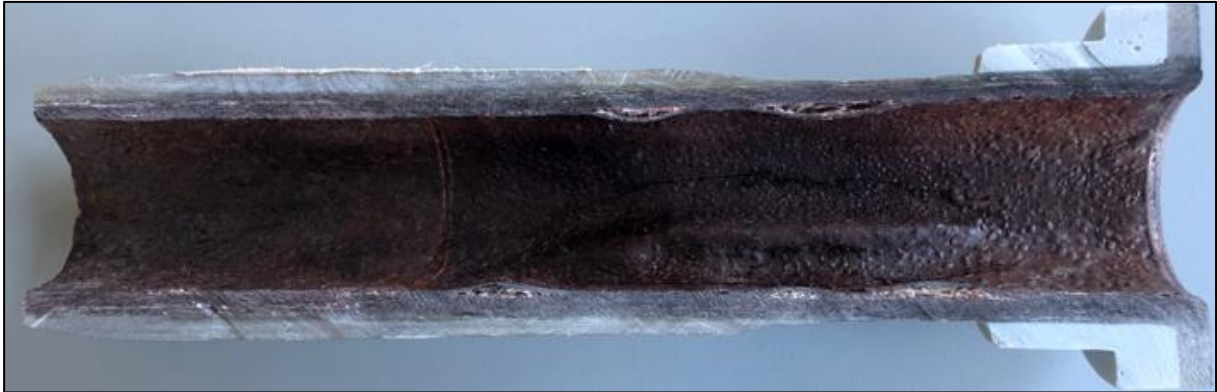
Figure L7. The online monitored pipe section showed severe material corrosion, which led to a changed signal for the lamb wave propagation.

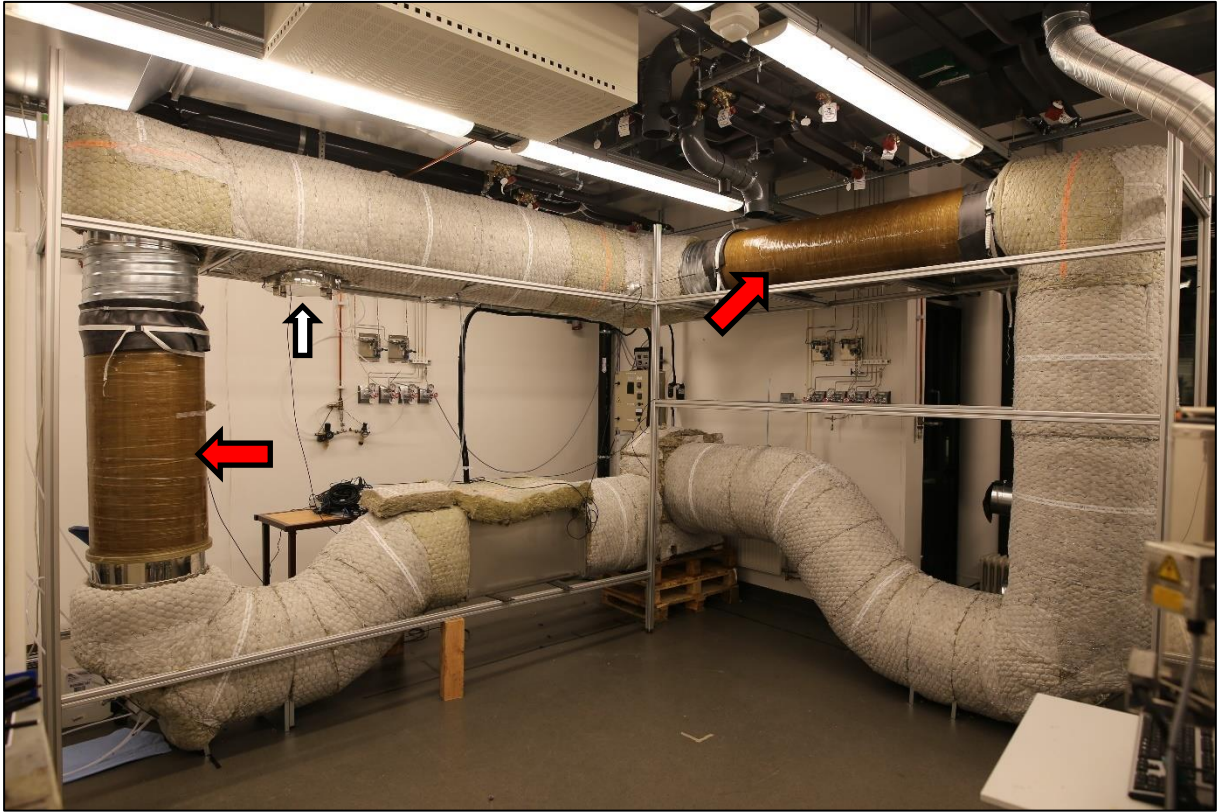
Figure L8. Constructed setup for testing of FRP under conditions similar to a by-pass operation in a flue gas stack. The red arrows indicate the FRP test pieces and the white arrow the position where test coupons can be inserted.

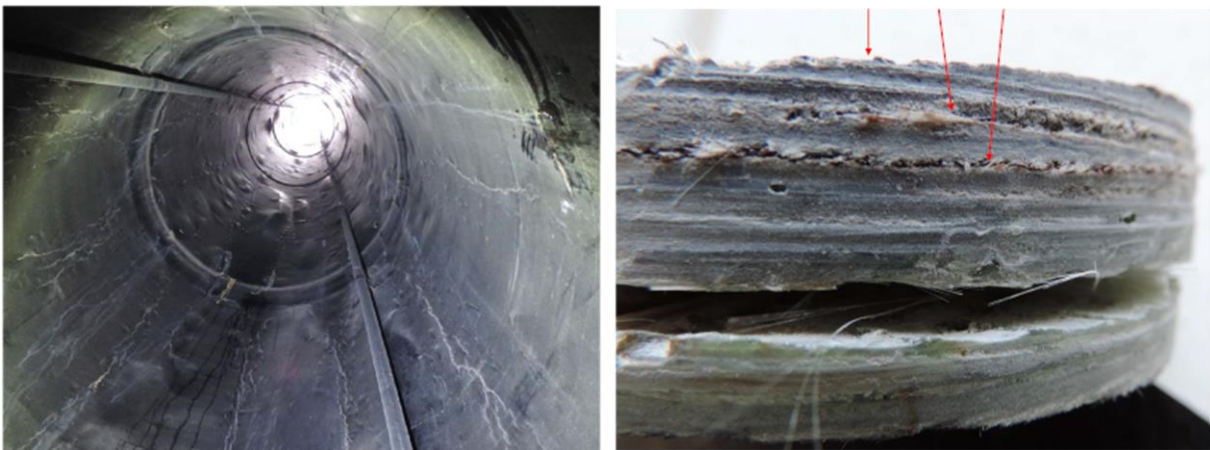
Figure L9. Severe delaminations seen as large buckles in a flue gas stack. L10. Cross-section of a delaminating FRP from a flue gas stack.

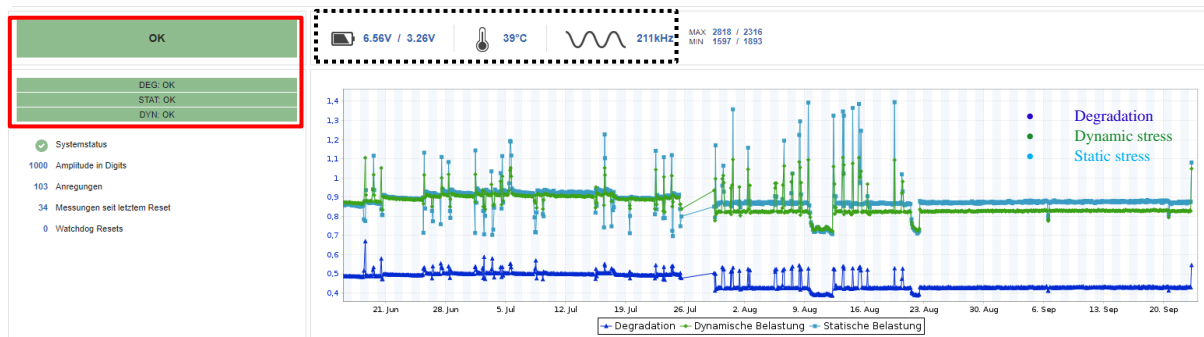
Figure 28. The dashboard for the sensor on the vertical test piece. Status is green and OK (red box to the left). Battery, temperature and frequency employed in the dashed box. The plot shows degradation, static and dynamic stress used to monitor structural health of the FRP-construction.

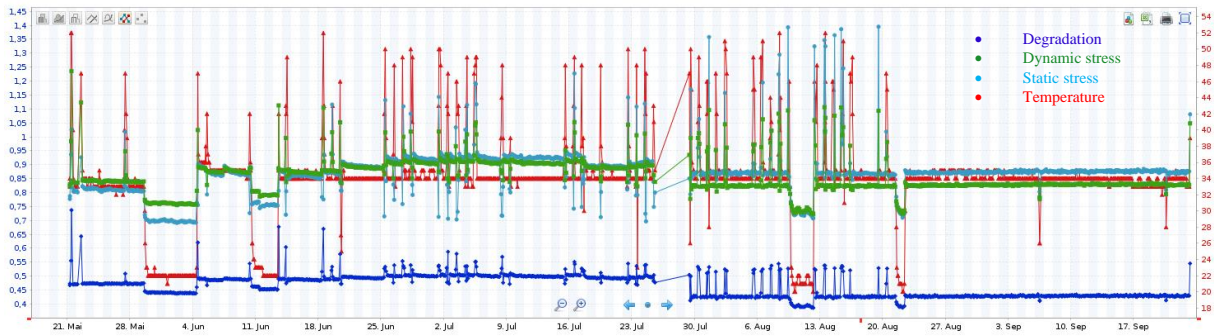
Figure L12. The temperature (red) is added to the plot, and it can be seen that the temperature has a large influence on the response of the other parameters.

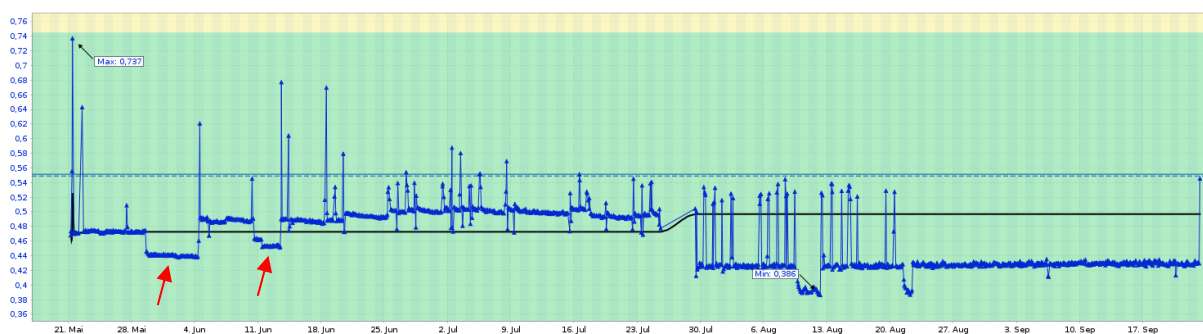
Figure L13. The degradation as monitored. Red arrows indicate positions when the test bed was turned off and thus had cooler temperature.

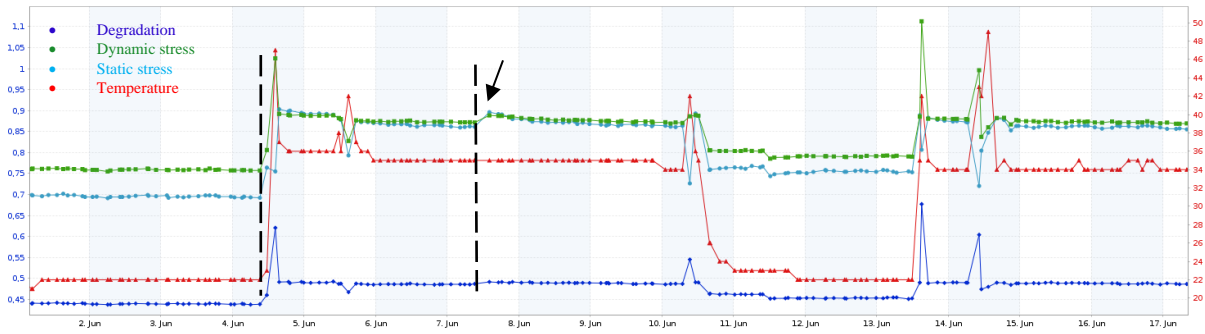
Figure 29. L14. The dashed lines indicate time positions when different damages were introduced to the FRP-stack.

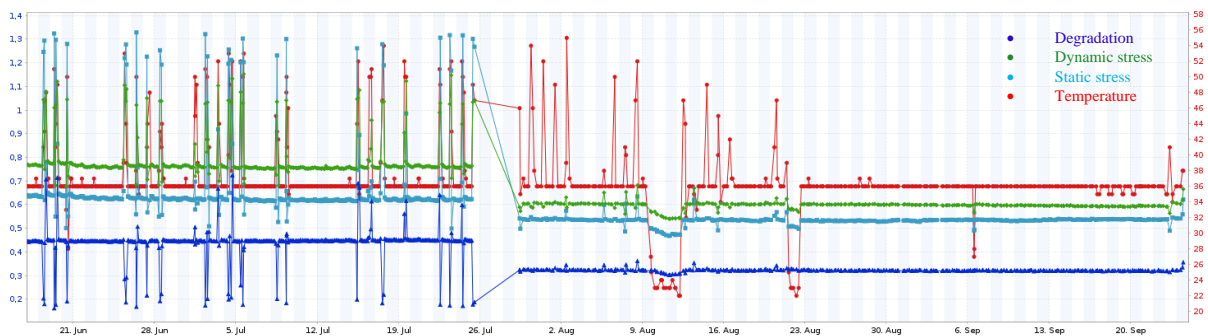
Figure L15. The monitoring of the temperature, degradation, static and dynamic stress over a time period of four months. No long-term changes in the material structure was seen during the time, even though it been cycled to temperatures above 180 °C more than 150 times.

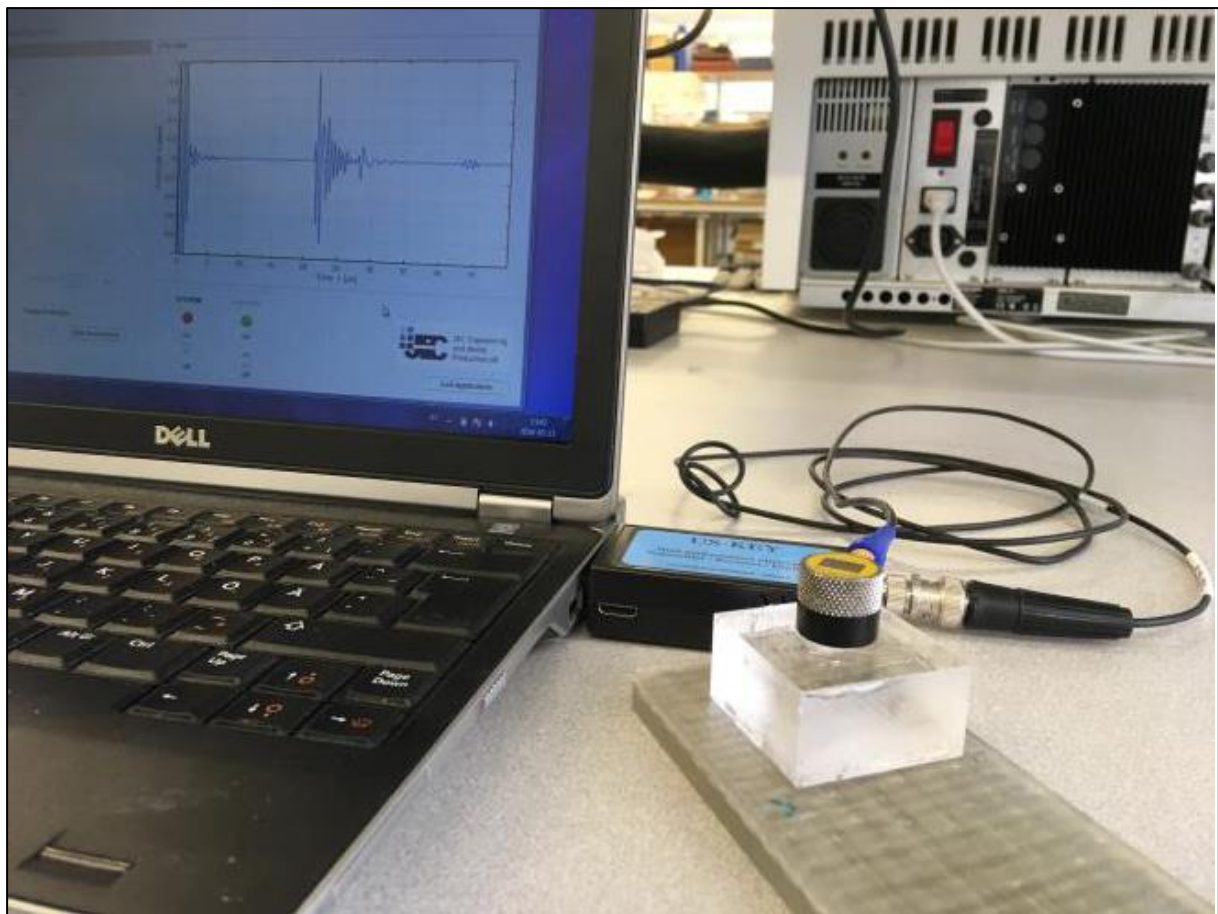
Figure 30. The experimental setup for the ultrasound testing of samples using the small probe together with the USB software.

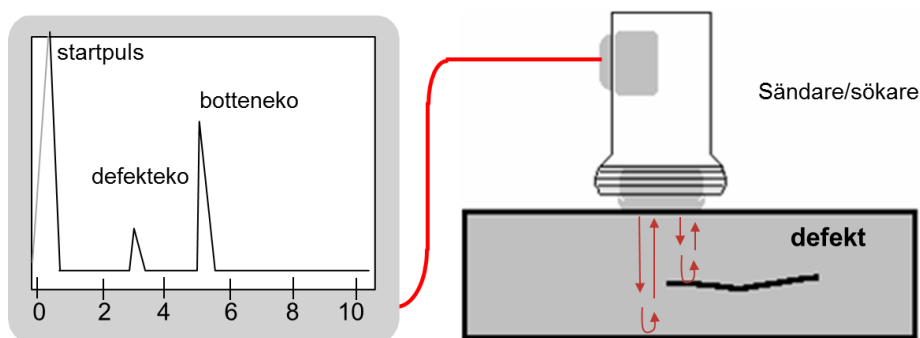
Figure 31. Schematic picture of how ultrasonic measurements works.

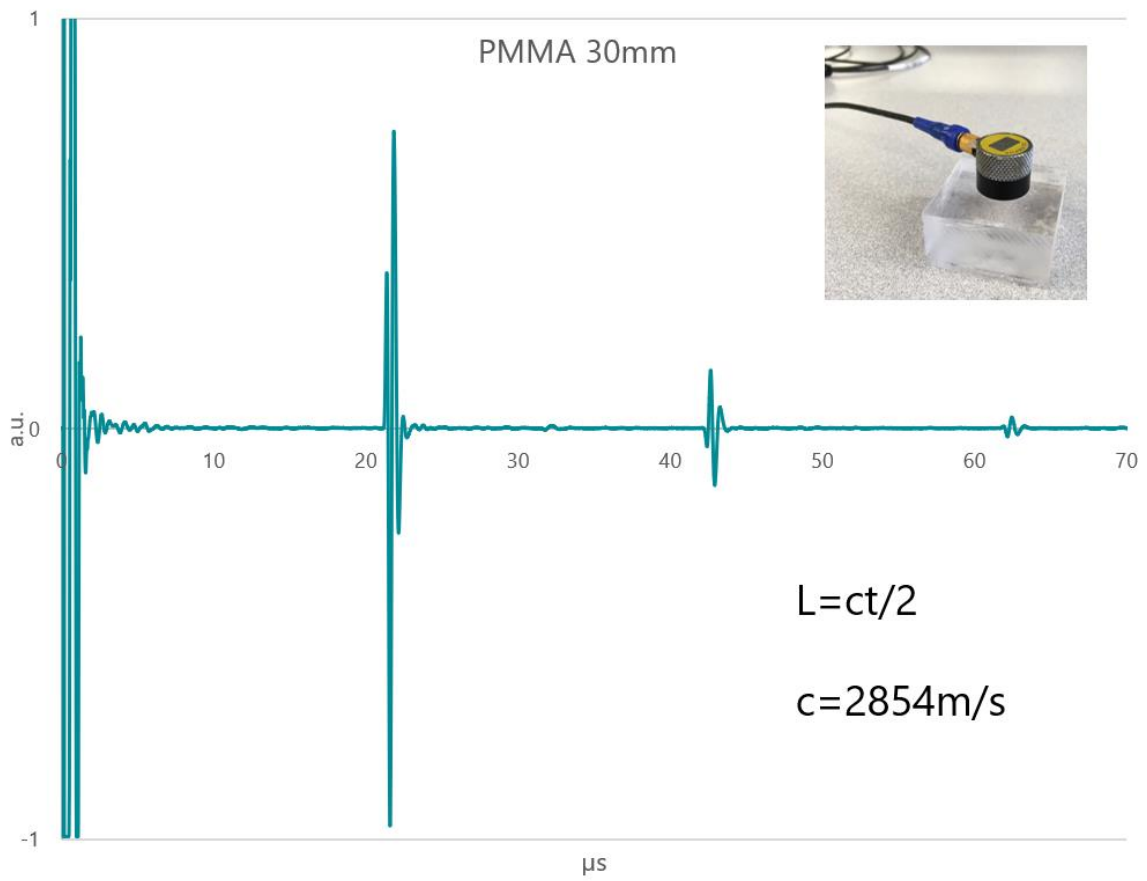
Figure 32. The echo recorded from a PMMA cube.

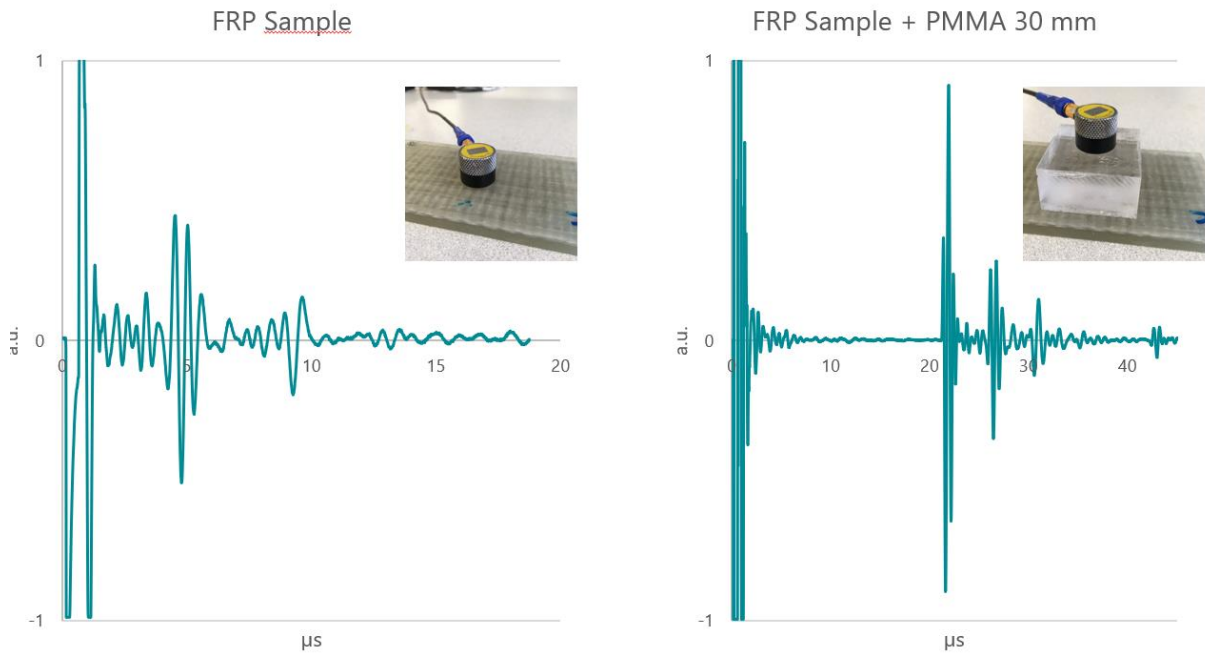
Figure 33. The echoes from an FRP sample (to the left) and from an FRP sample with PMMA cube (to the right).

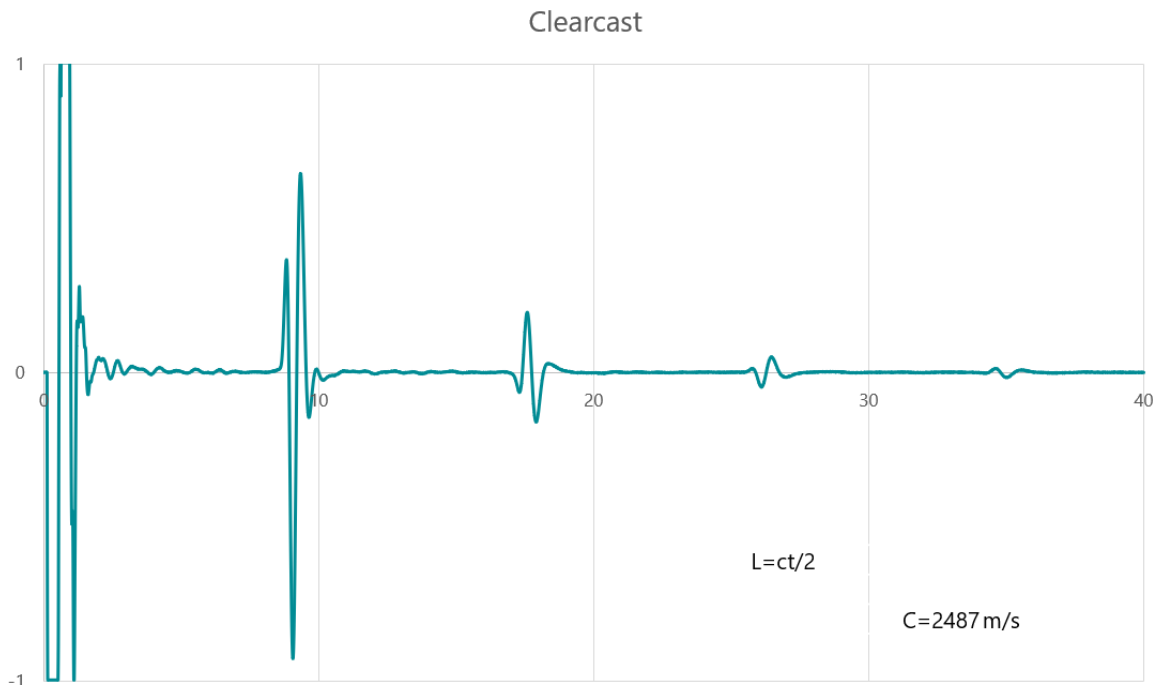
Figure 34. The echo recorded from a sample made of clear cast with no glass fibres.
